20 Pump Fire – New Providence Wharf

New Providence Wharf
1 Fairmont Avenue
London E14 9PL
Borough of Tower Hamlets

Date of Incident: 7 May 2021

Date of report: 27 June 2022

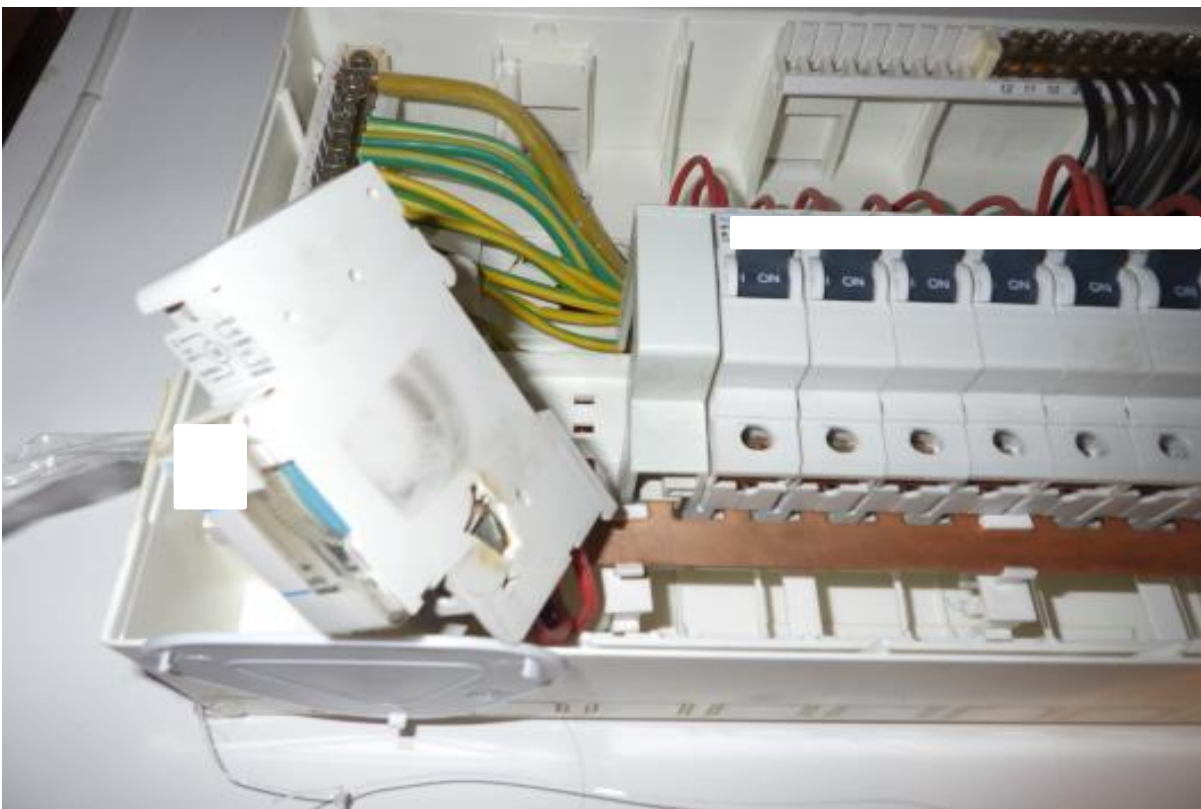
The use of plastic enclosures/cases for consumer units within buildings of this age is common. LFB in partnership with stakeholders have previously highlighted their concern about the flammability of such enclosures and this led to a new regulation (BS7671) requiring consumer units and similar switchgear assemblies in domestic premises to have a non-combustible (e.g. metal) enclosure which was implemented on 1st January 2016 (but was not retrospective).

Evidence from other flats within block D have highlighted an area for further investigation with the use of timing switches within the original configuration of the consumer unit. The timing switches were used to supply an immersion heater within the hot water cylinder and work is underway to confirm the timer switch's suitability to be connected to such an electrical load, or if any other issues exist that relate to public safety.

Image showing an exemplar plastic consumer unit found in flat on 9th floor with an internal heating fault on the Timer Switch

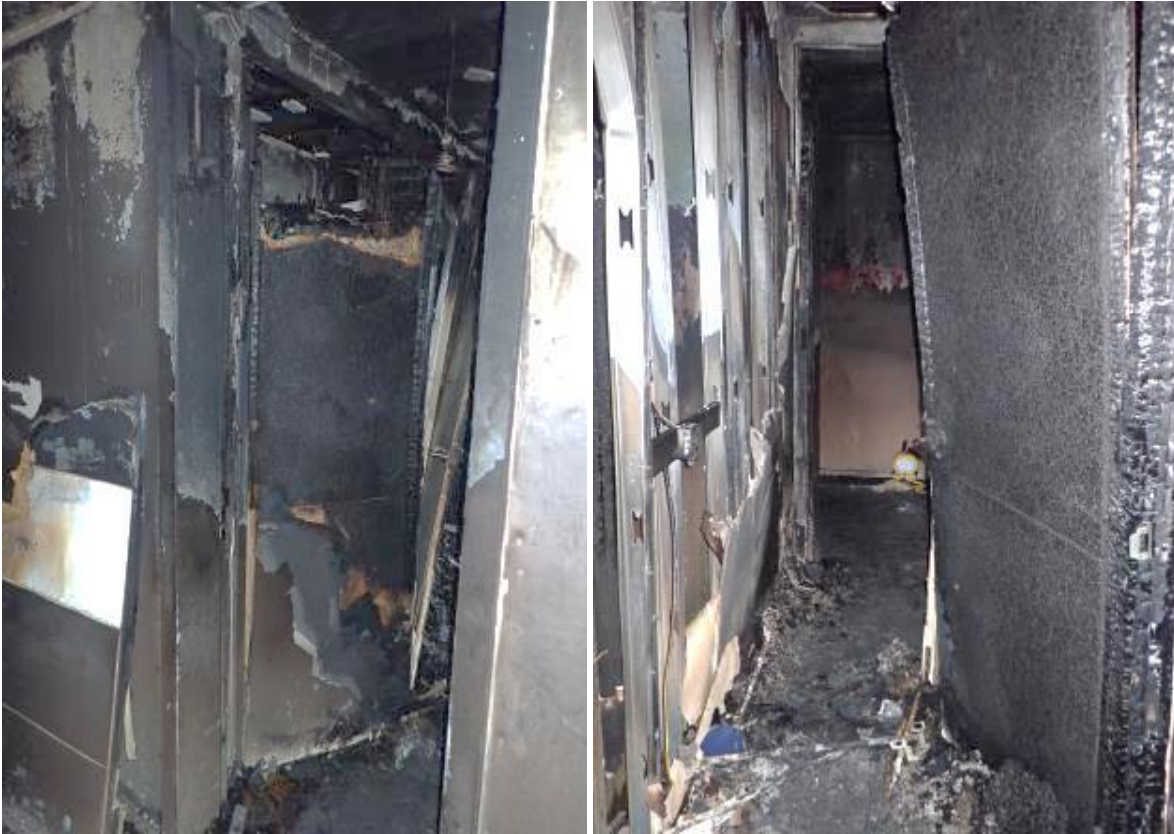
Once ignited, the plastic case of the consumer unit would lead to burning droplets igniting other combustible items within the cupboard. A number of burning items fell out from the cupboard containing the consumer unit when it was opened and the fire was discovered, preventing the cupboard door from closing. Due to the balcony door being open and the likelihood of items being inadvertently knocked in front of the flat door preventing it from closing, the additional airflow would have supported the fire's development.

Images showing the front entrance (looking from outside) and hallway (looking from inside) of flat. Note the remains of the door to the left of the doorway

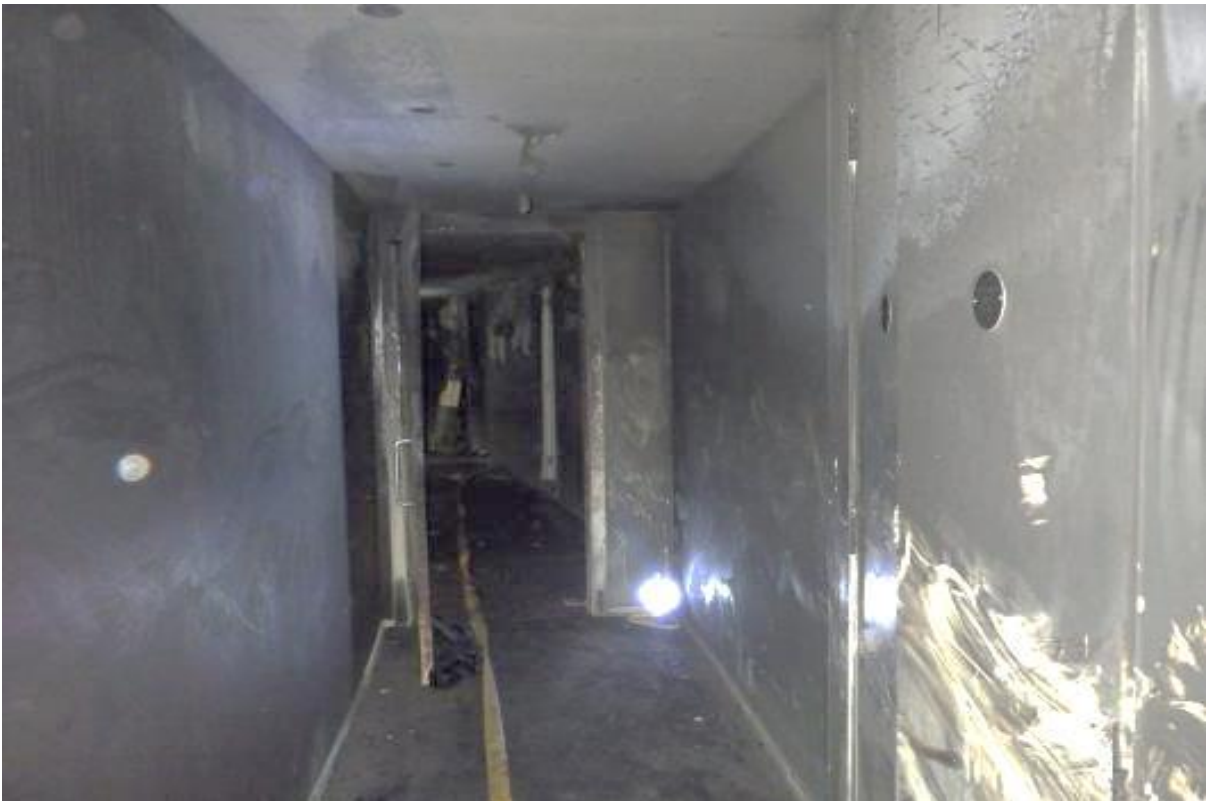
The smoke detectors within block D's common parts should have operated the AOV and cross corridor doors on the 8th floor, However, it is known that none of these systems actuated. This allowed smoke and the products of combustion to flow through the common parts of the 8th floor (and subsequently beyond) making it difficult/impossible for persons on this floor to escape safely, while increasing the challenges and risks for firefighting and search and rescue operations within the building.

Images showing the 8th floor corridor looking towards the flat of origin

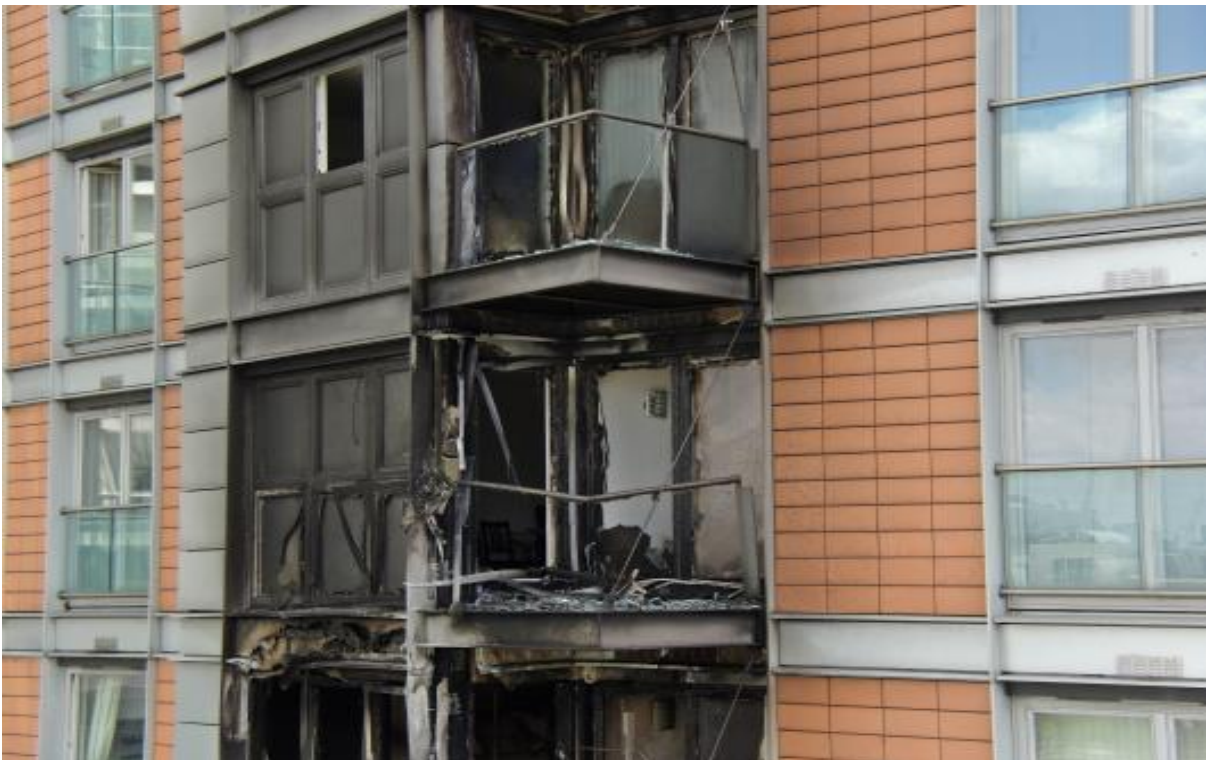
Fire was also able to travel externally from the 8th to the 11th floors after spreading through the open balcony door of the flat of origin.

Image showing the external fire damage on the 9th and 10th floors

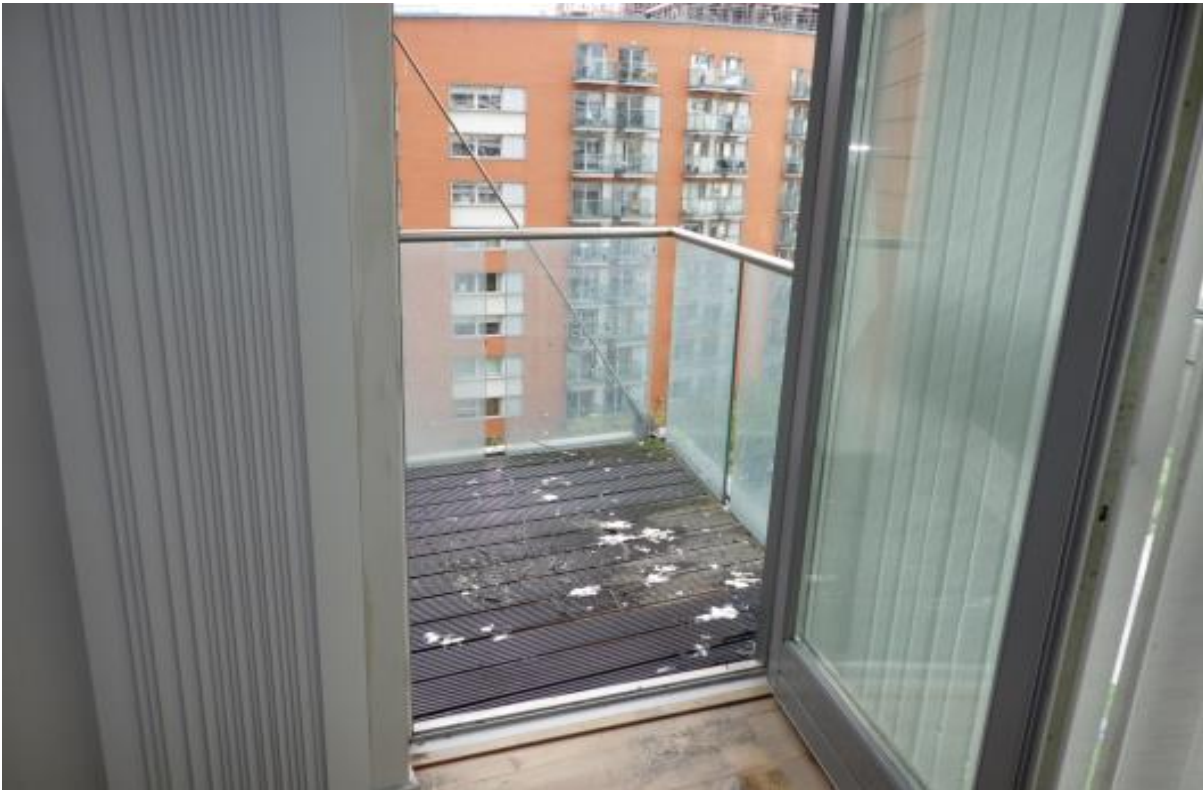
Image showing the construction of an undamaged balcony

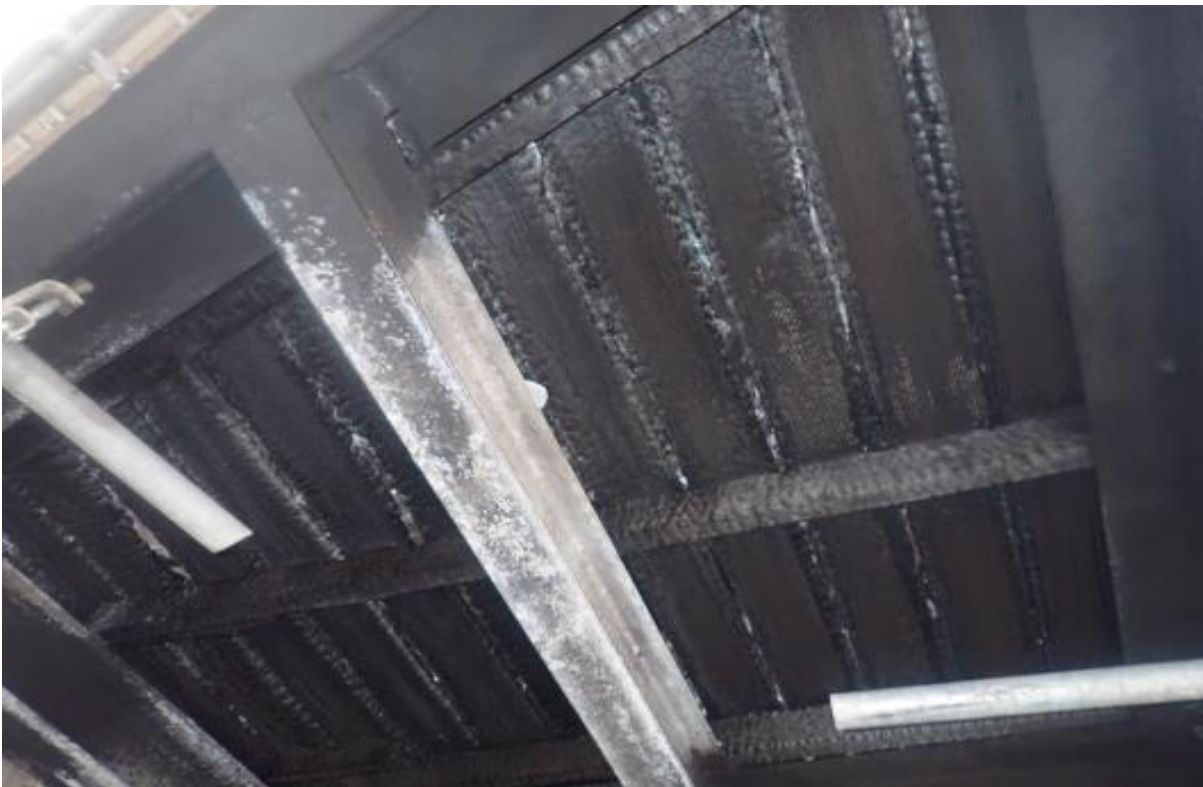
The timber decking of the balcony supported the external flame spread up the outer face of the building. Although some ACM panels were involved, in this instance they did not significantly contribute to the external spread of the fire.

Image showing the charring to the underside of the 9th floor balcony timber decking

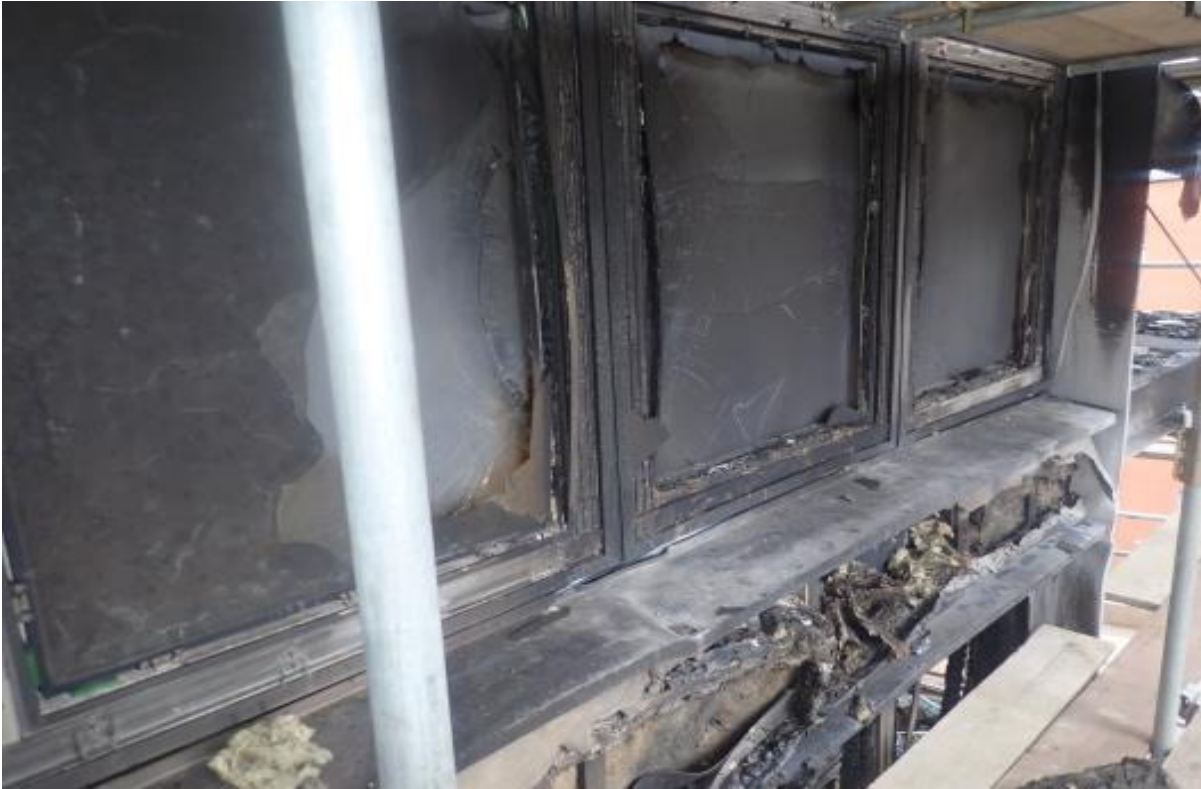
Image showing the damage to the ACM cladding between the 8th and 9th floor windows

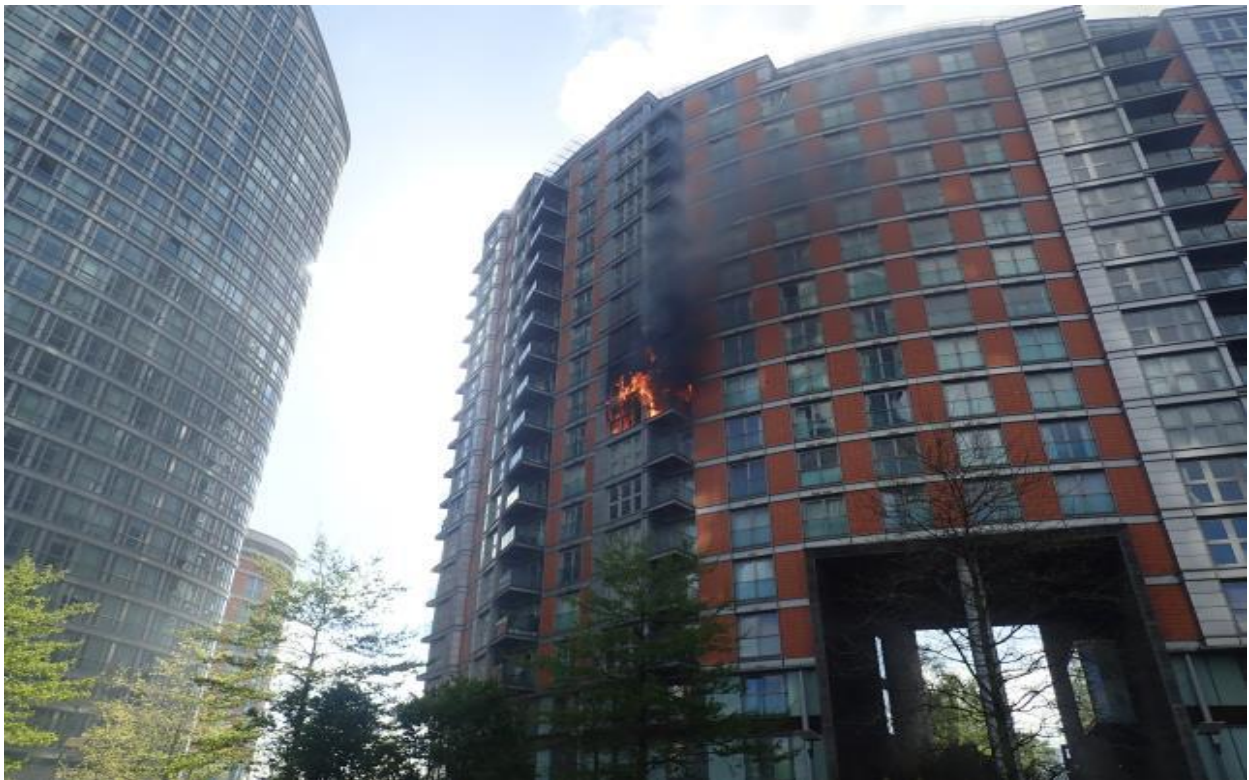
Image showing the fire in progress on the North face of NPW

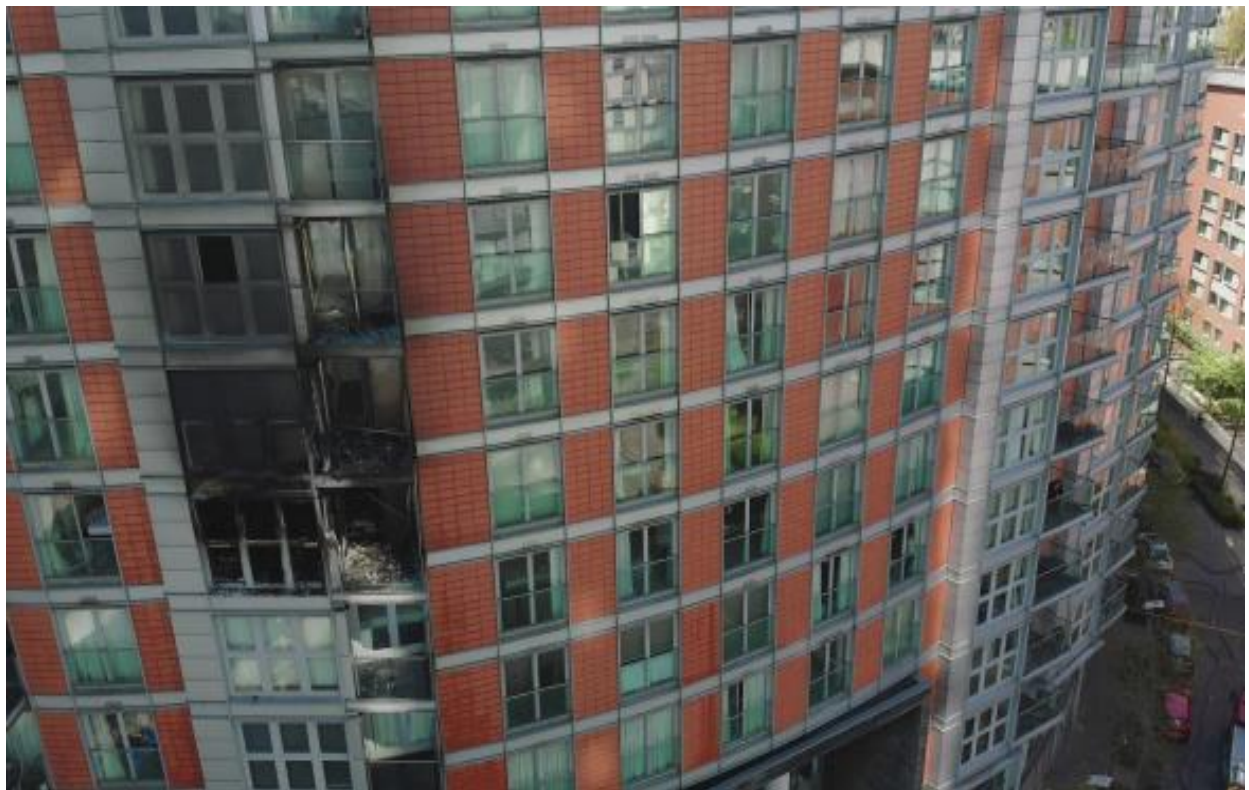
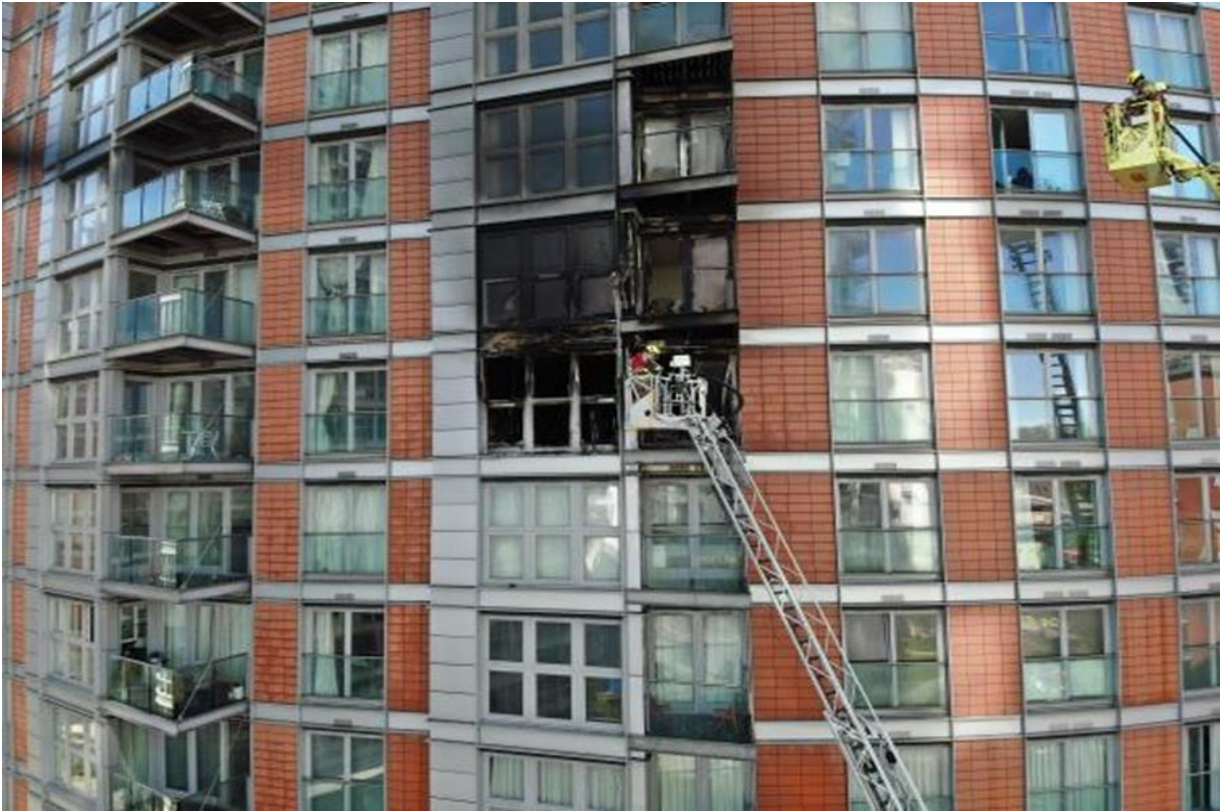
Images showing the damage to the exterior North face of NPW

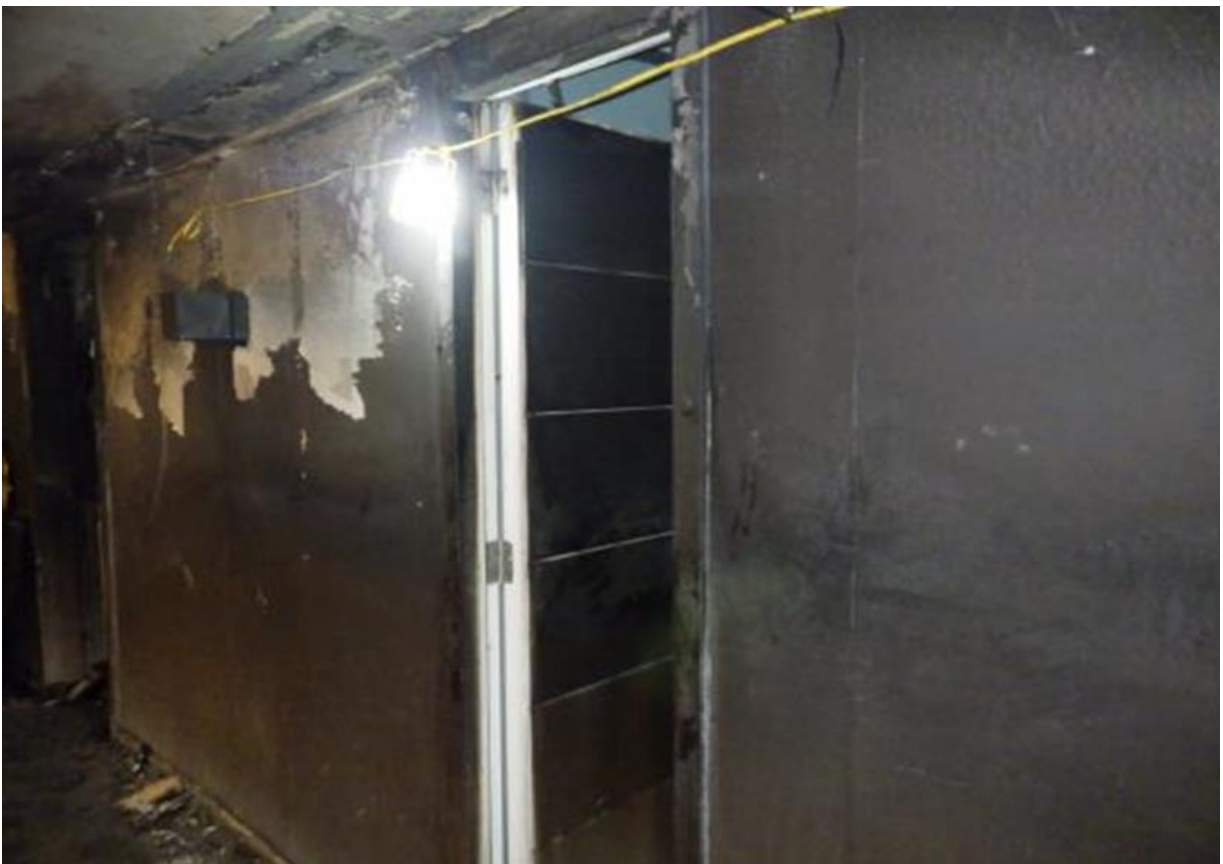
Image showing the AOV door on the 8th floor

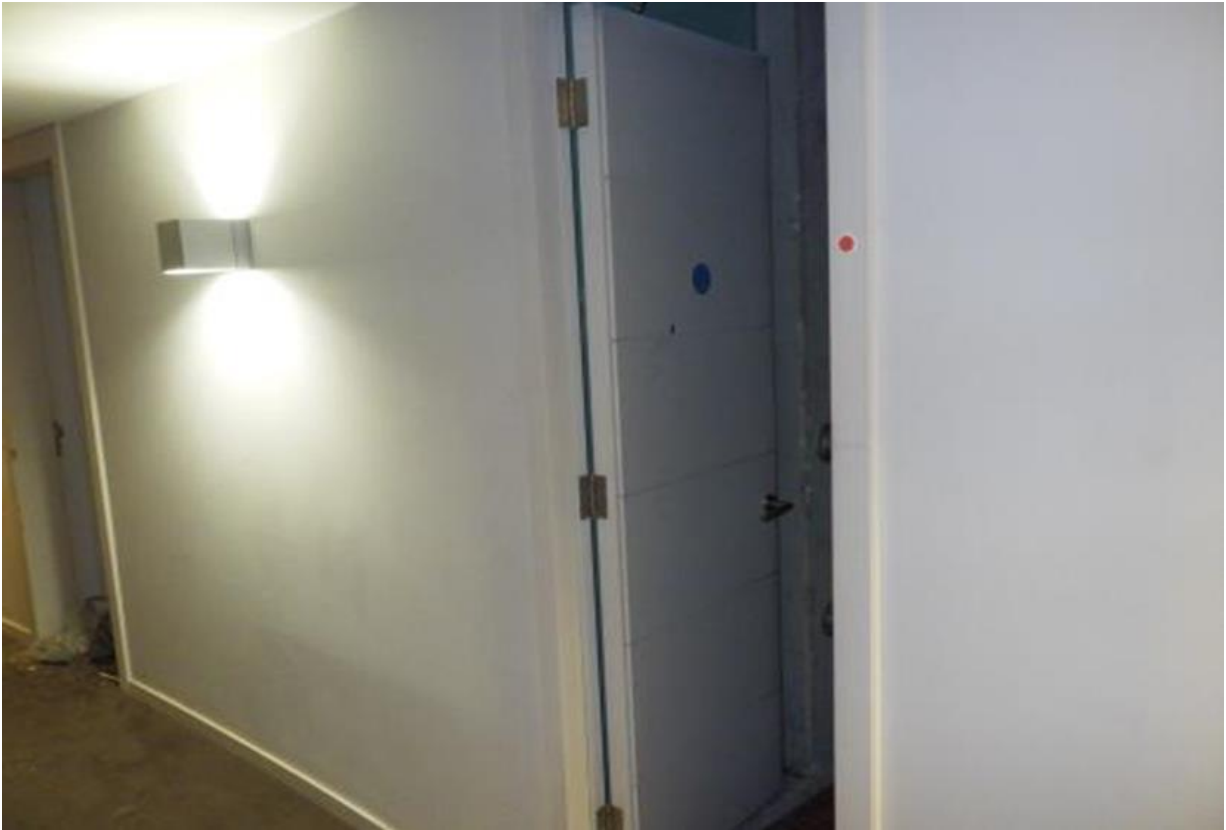
Image showing the AOV door on the 9th floor

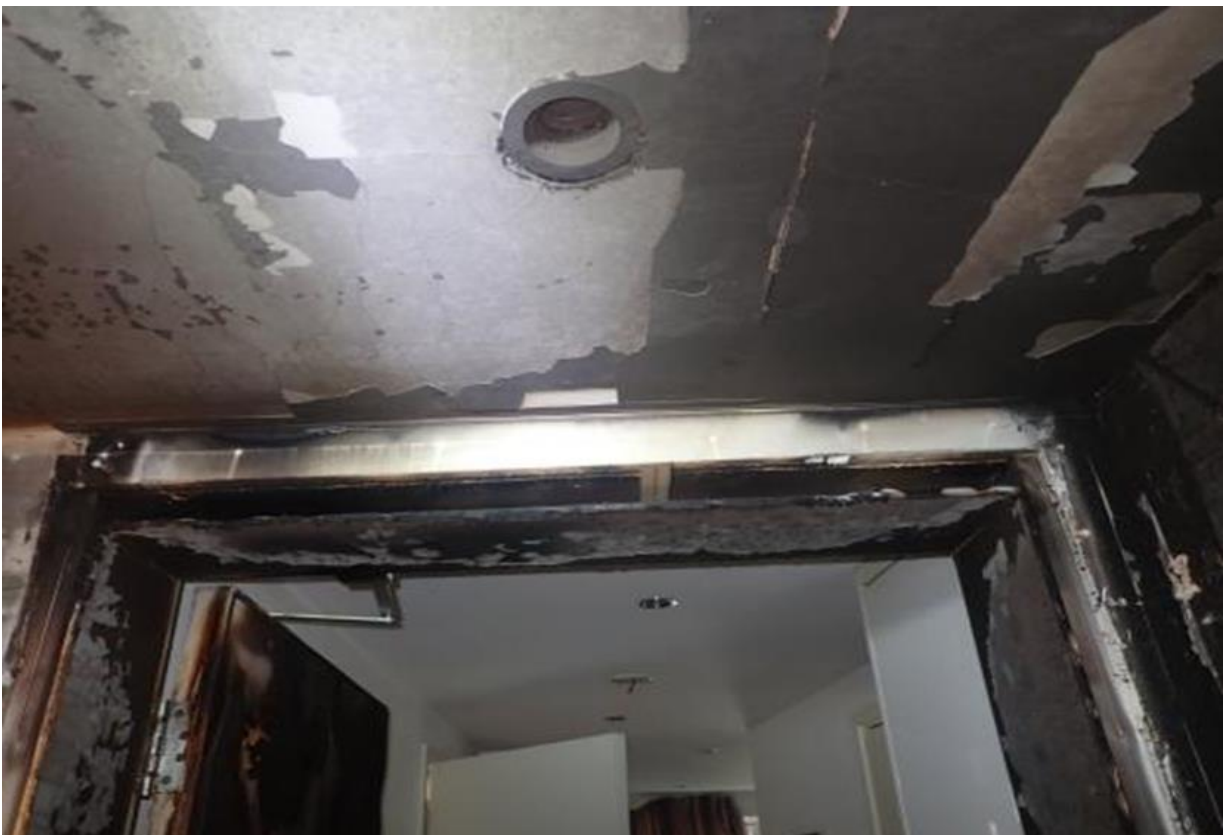
Image showing the void between the top of the door frame and the fabric of the building

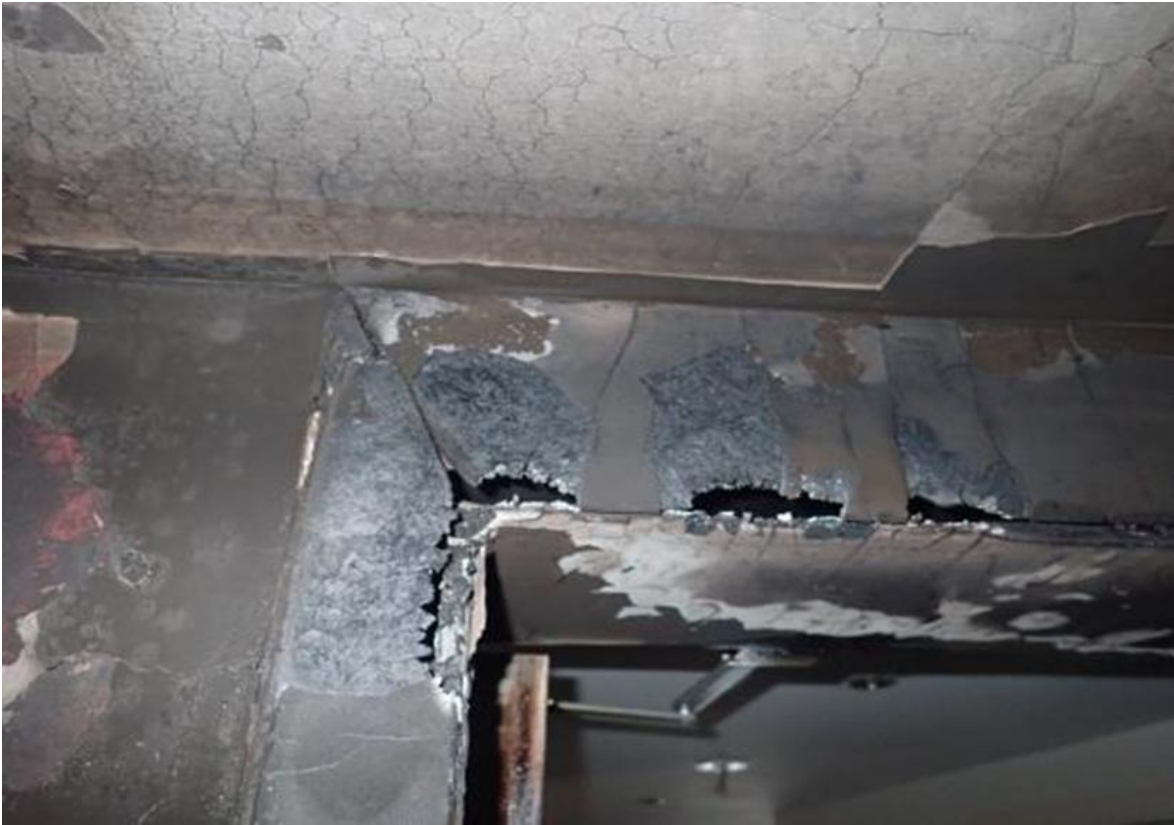
Image showing the timber boxing around the front door frame of flat next to flat of origin
