**Freedom of Information request reference number:** 4466.1

CLADDING INVESTIGATIONS

ROYAL ARTILLERY QUAY

Report Ref. 18086/1

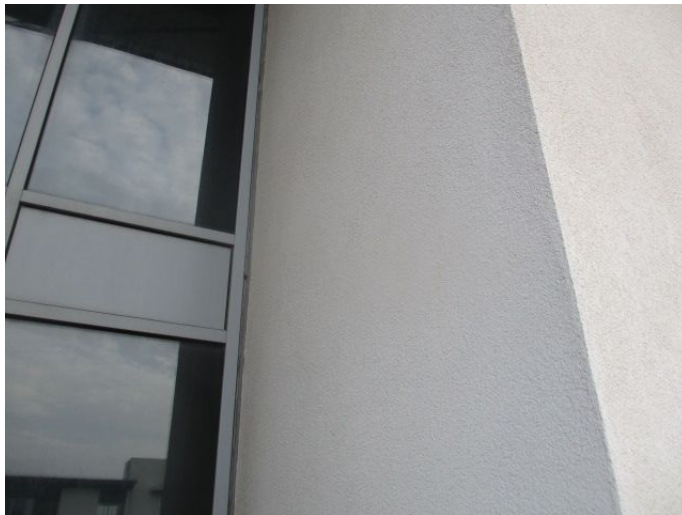
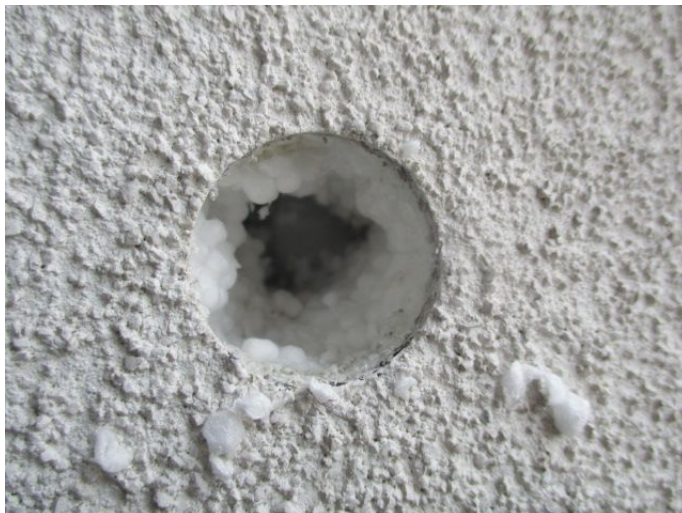
2 – Location 1 – Tideslea Flat (L 14).

1. Tideslea Tower – Flat [REDACTED] – 14<sup>th</sup> Floor (wall between the West balcony and the stairwell)
  - The cladding build-up comprised:
    - Render (2-3mm) (Sample 1/B removed)

- Insulation (circa 75mm) (Sample 1/A removed)
    - Concrete (no obvious cavity)
  - No cavity/fire barriers were noted
2. Tideslea Tower – Flat [REDACTED] – 5<sup>th</sup> Floor (front wall to terrace)

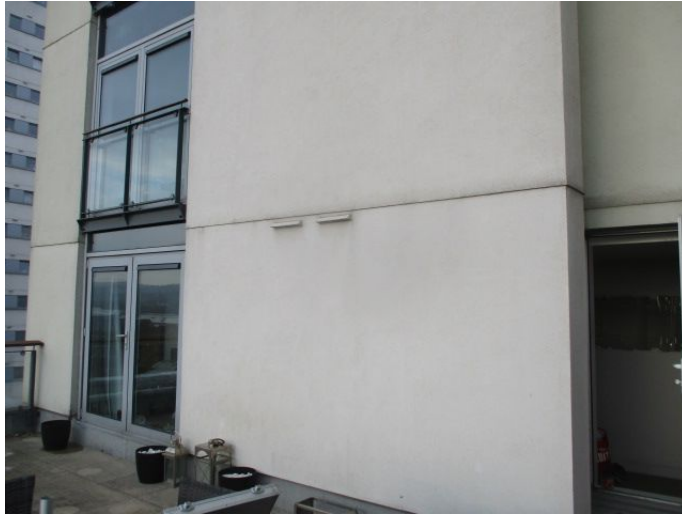
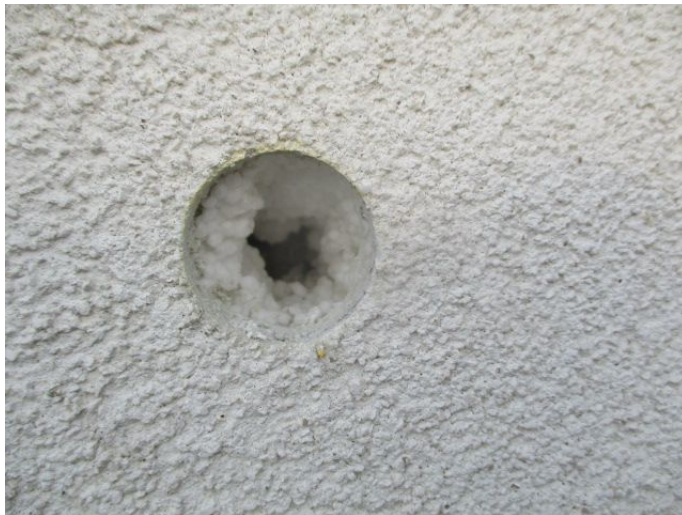
4 – Location 2 – Tideslea Flat (L5)

- The cladding build-up comprised:
    - Render (2-3mm)
    - Insulation (circa 75mm) (sample 2 removed)
    - Concrete (no obvious cavity)
  - An inspection hole drilled at 6<sup>th</sup> floor slab level revealed the present of a horizontal mineral wool fire barrier. The render was 5-6mm thick at this location.

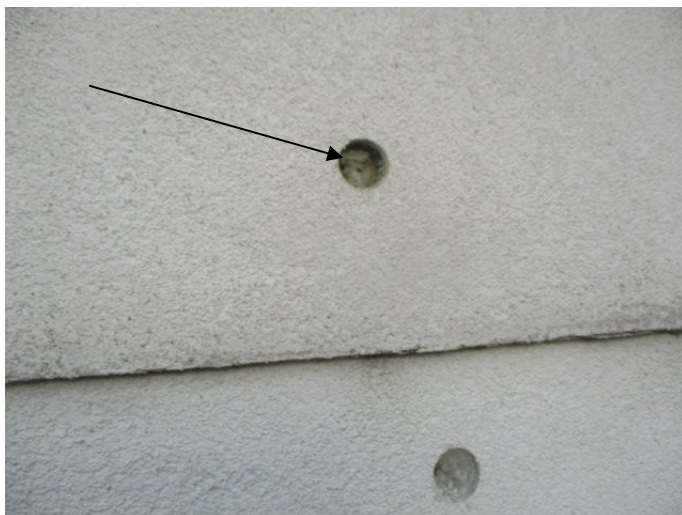
6 – Location 2 – Mineral wool horizontal barrier

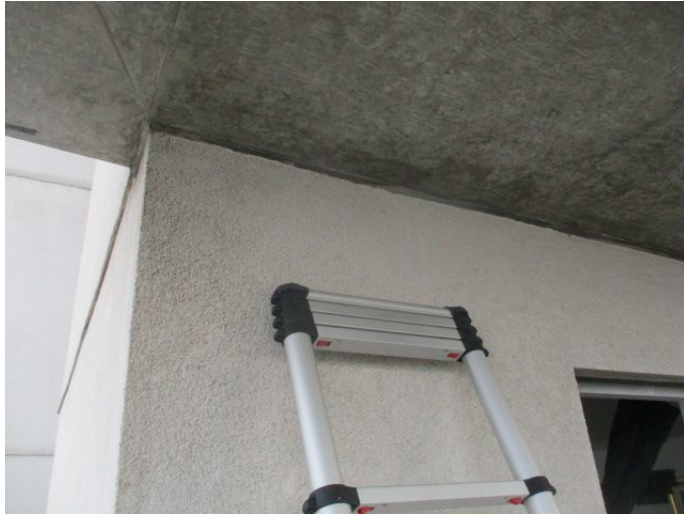
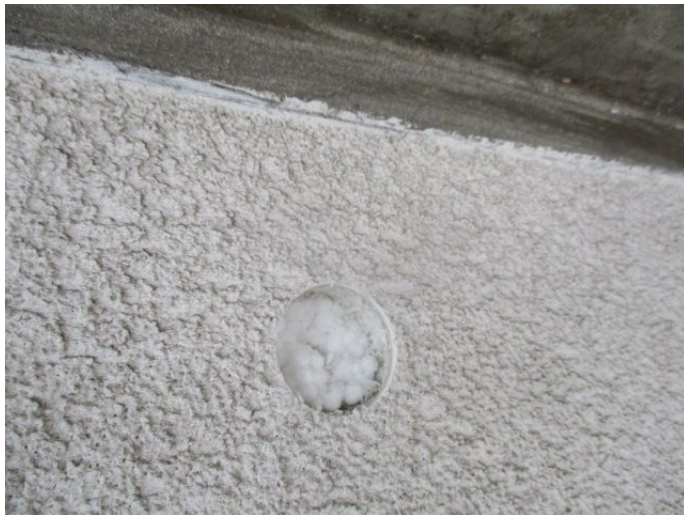
7 – Location 3 – Tideslea Flat (L2)

3. Tideslea Tower – Flat [REDACTED] – 2<sup>nd</sup> Floor (rear balcony wall)
  - The cladding build-up comprised:
    - Render (2-3mm)
    - Insulation (circa 75mm)

- Concrete (no obvious cavity)
  - No cavity/fire barriers were noted.
4. Tidlock House – Flat [REDACTED] – 4<sup>th</sup> Floor (front wall to terrace)

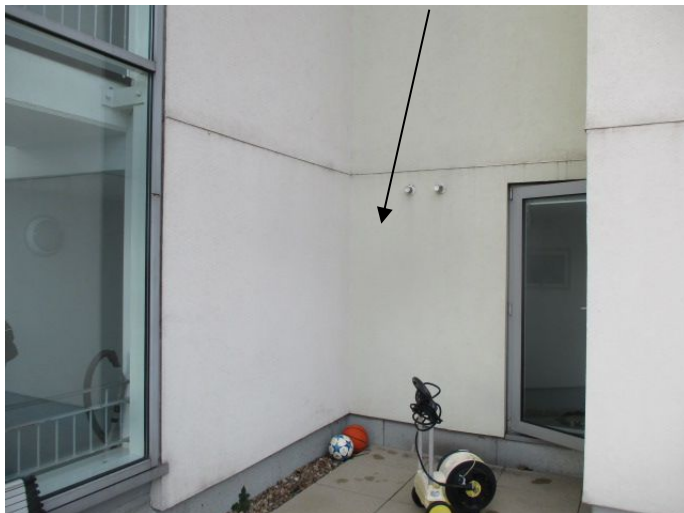
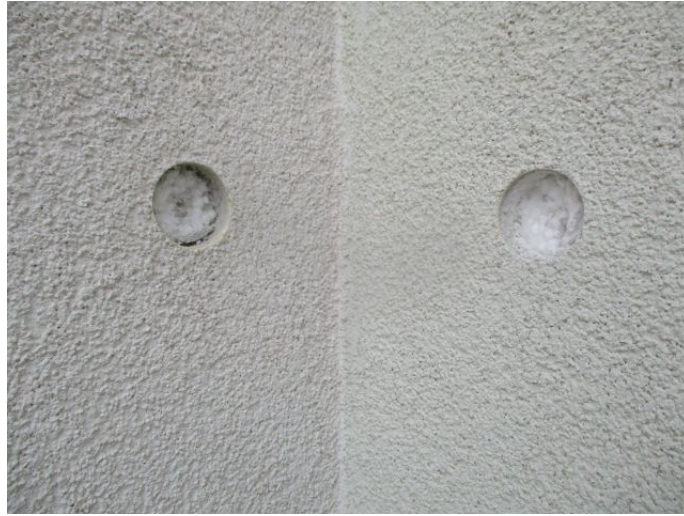
9 – Location 4 – Tidlock Flat (L4)

- The cladding build-up comprised:
    - Render (2-3mm) (sample 3/B removed)
    - Insulation (circa 75mm) (sample 3/A removed)
    - Concrete (no obvious cavity)

- Above the terrace access door there was a condensate pipe that penetrated the render. This was apparently unsealed.
  - No vertical fire/cavity barriers were noted.

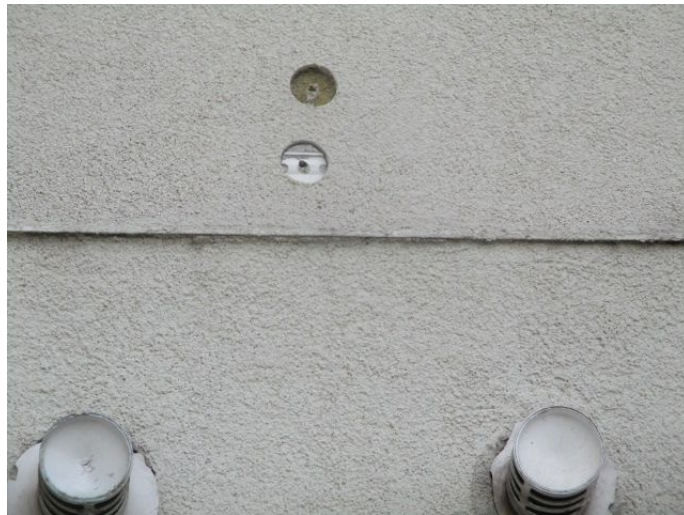
- An inspection hole drilled at 5<sup>th</sup> floor slab level revealed the present of a horizontal mineral wool fire barrier. The render was 5-6mm thick at this location.

11 – Location 4 – Horizontal rockwool barrier

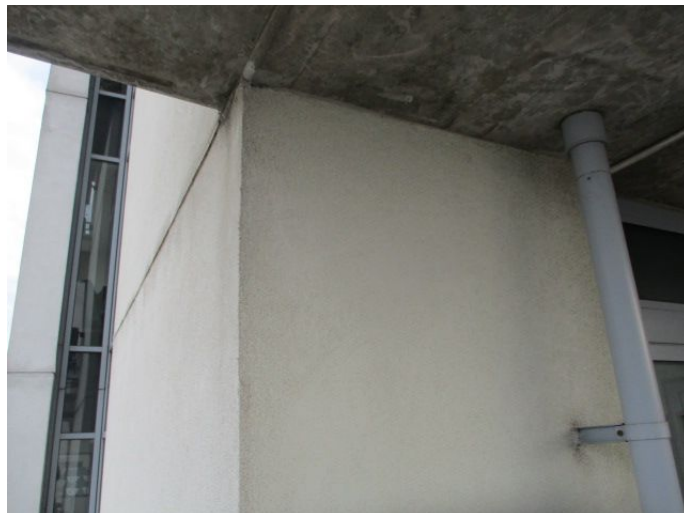
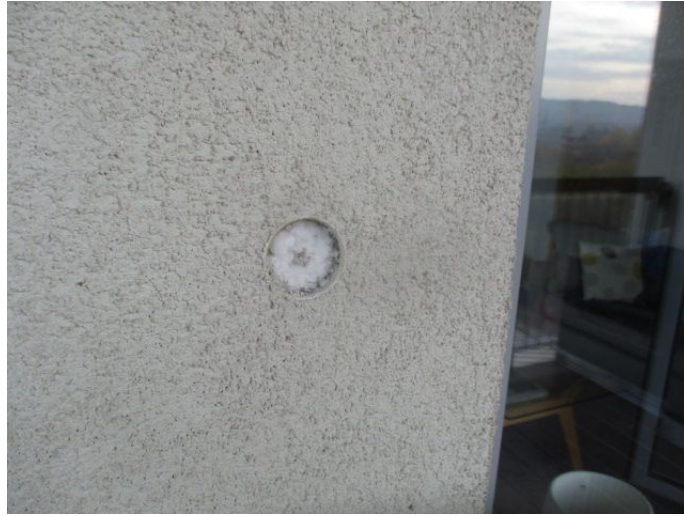
12 – Location 5 – Tidlock Fla [REDACTED] – L5

5. Tidlock House – Flat [REDACTED] – 5<sup>th</sup> Floor (rear wall to balcony)
- The cladding build-up comprised:
    - Render (2-3mm)
    - Insulation (circa 75mm) (sample 4 removed)

- Concrete/masonry (no obvious cavity)
  - No cavity/fire barriers were noted.
6. Tidlock House – Flat [REDACTED] – 7<sup>th</sup> Floor (rear wall to balcony)

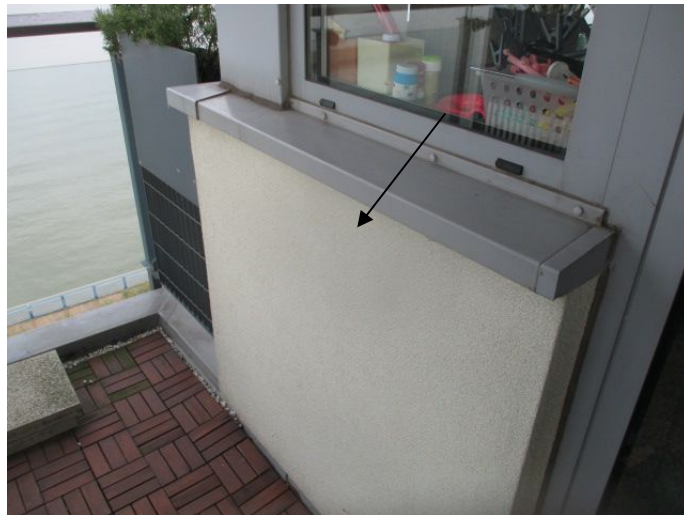
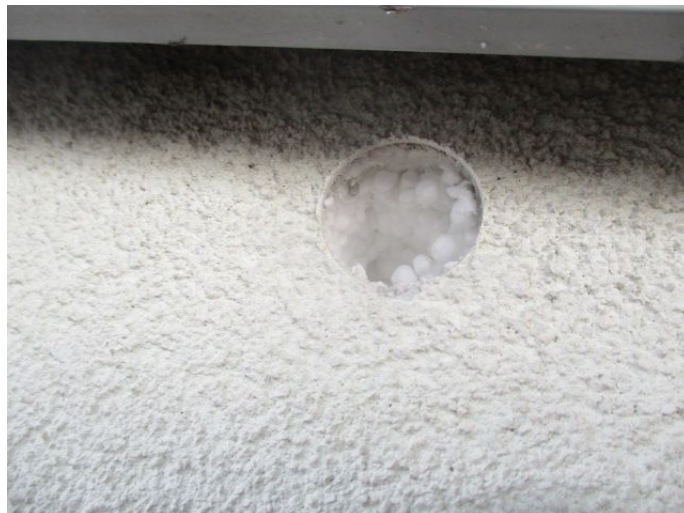
14 – Location 6 – Tidlock – Flat [REDACTED] (L7)

- The cladding build-up comprised:
    - Render (2-3mm)
    - Insulation (circa 75mm)
    - Concrete/masonry (no obvious cavity)
  - No cavity/fire barriers were noted.

- No barrier beneath the window cill was noted.
  - The insulation was exposed to the render panel along its lower edge.
7. Bendish Point – Flat [REDACTED] – 9<sup>th</sup> Floor (wall between the west balcony and stairwell)

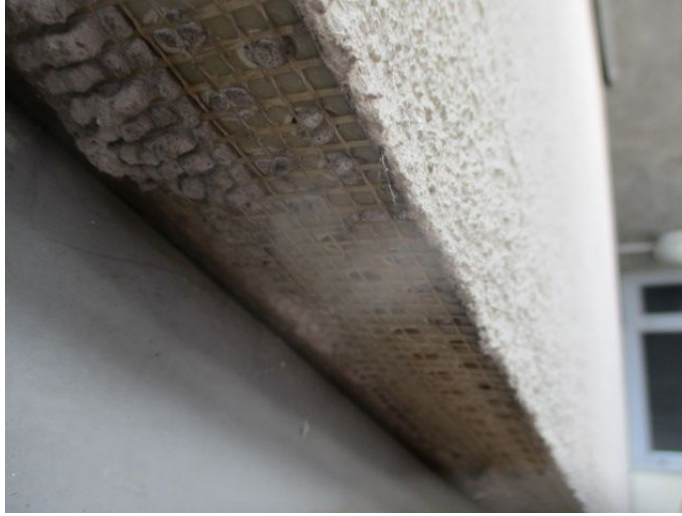
The insulation was also exposed at the base of some render panels.

In these areas the flammable insulation would potentially be exposed.

16 – Location 6 – Insulation exposed beneath panel

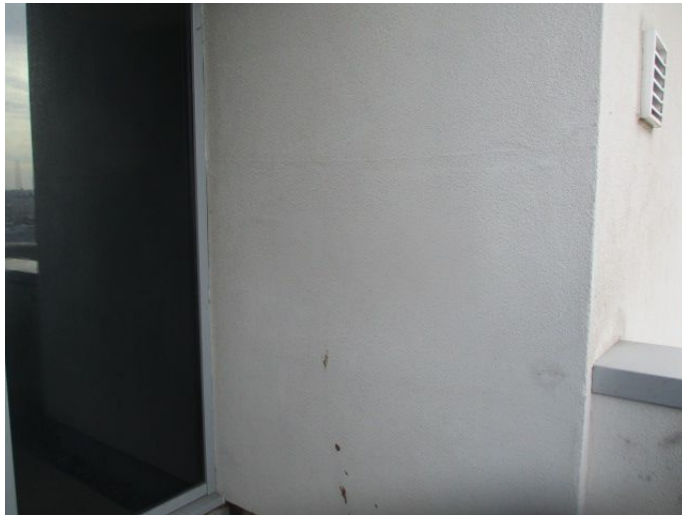
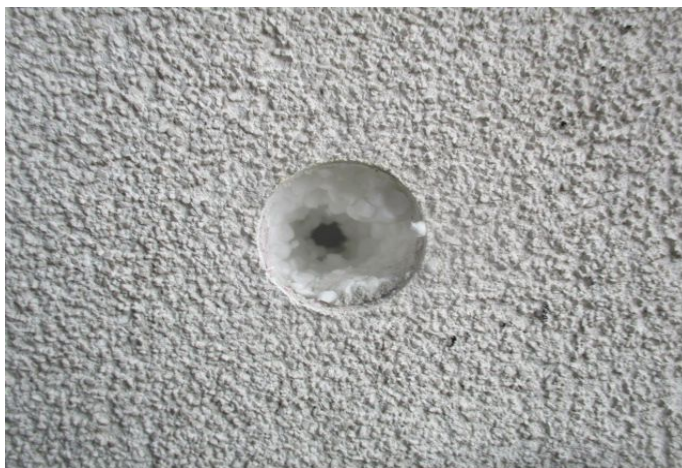
17 – Location 7 – Bendish Flat (L9)

- The cladding build-up comprised:
    - Render (2-3mm) (sample 5/B removed)
    - Insulation (circa 75mm) (sample 5/A removed)
    - Concrete/masonry (no obvious cavity)

- No cavity/fire barriers were noted.
8. Bendish Point – Flat [REDACTED] – 8<sup>th</sup> Floor (rear balcony wall)
- The cladding build-up comprised:
    - Render (2-3mm)

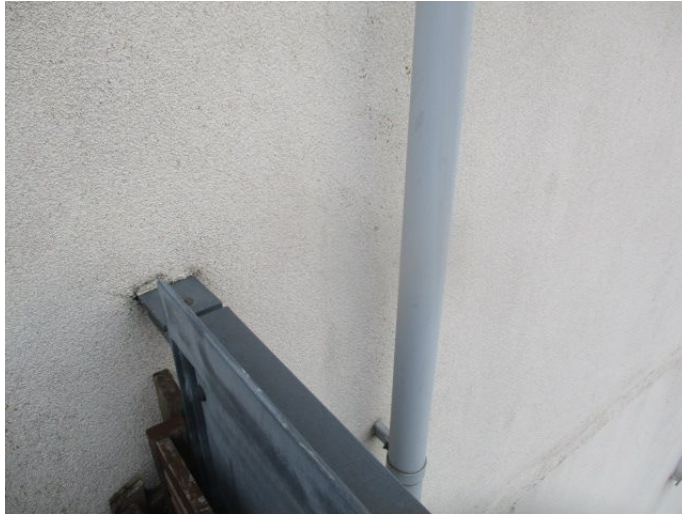
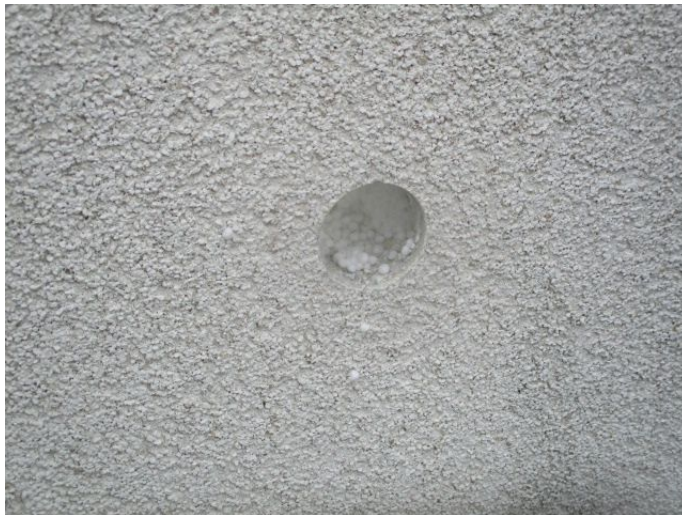
18 – Location 10 – Bendish Flat (L8)

- Insulation (circa 75mm) (sample 6 removed)
    - Concrete/masonry (no obvious cavity)
  - No cavity/fire barriers were noted.
  - The insulation was exposed to the render panel along its lower edge.
-

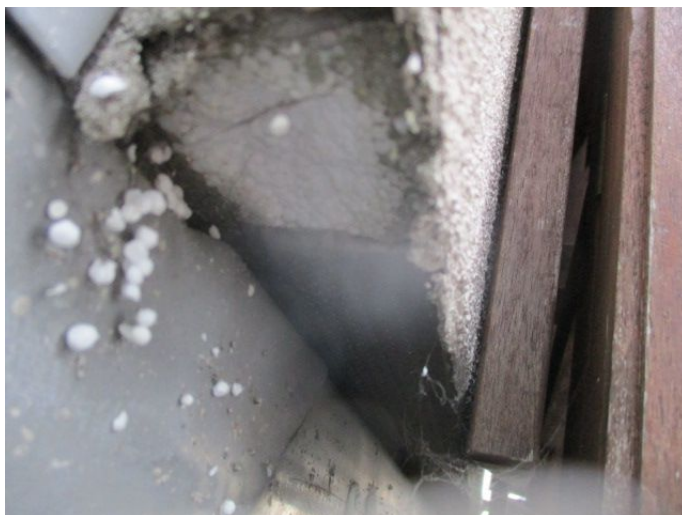
21 – Location 10 – Polystyrene insulation exposed at base of panel

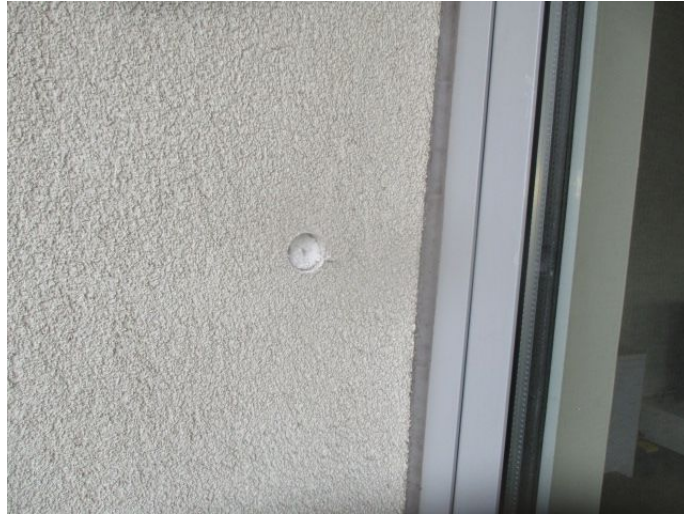
22 – Location 11 – Bendish Flat (L3)

- The cladding build-up comprised:
  - Render (2-3mm)
  - Insulation (circa 75mm) (sample 6 removed)
  - Concrete/masonry (no obvious cavity)

- No cavity/fire barriers were noted.

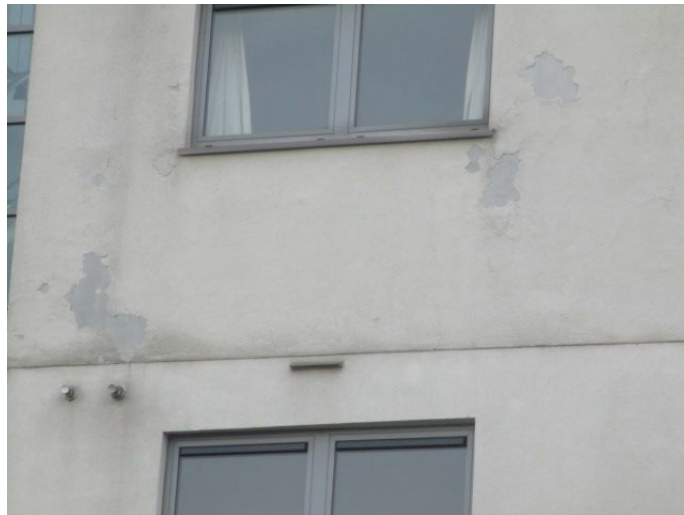
It was noted that the render coating was failing in places.

23 – Typical location where the render is failing.

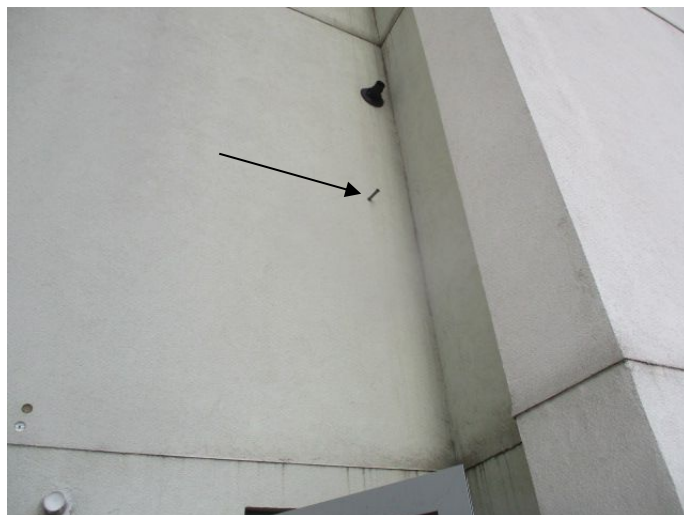
In addition, a number of unsealed pipe penetrations through the render were noted.

24 – Typical unsealed pipe through render (above Location 4)

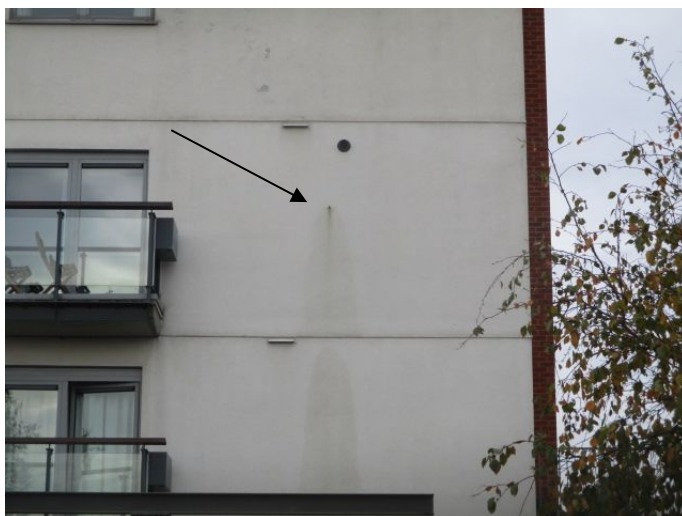
25 – Typical unsealed pipe through render.

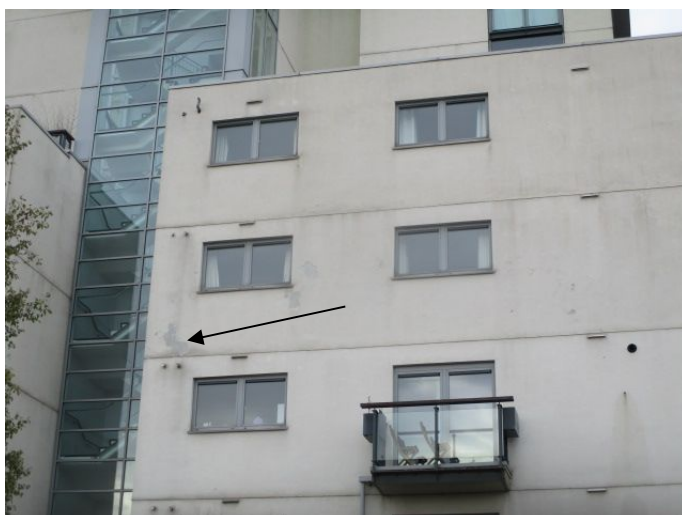
26 – Failing render

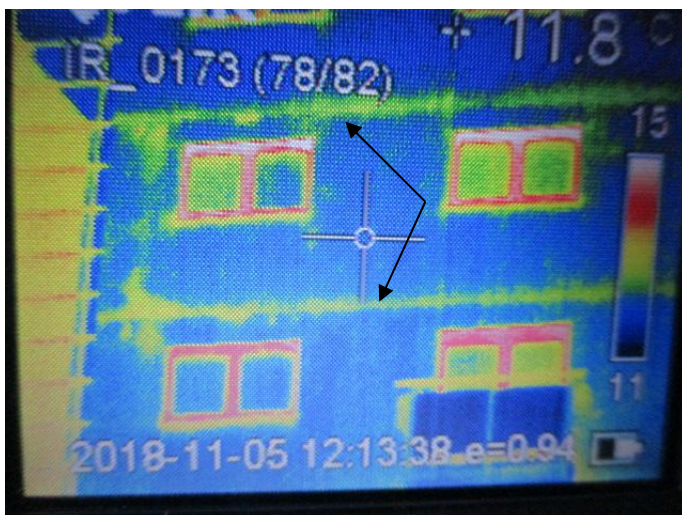
The scanning revealed the presence of horizontal linear thermal features at each floor level on each block that could be indicative of horizontal cavity/fire barriers.

No similar vertical features were identified.

27 – Typical thermal anomalies at slab level (possible cavity/fire barriers ?).
