20 Pump Fire – New Providence Wharf

New Providence Wharf
1 Fairmont Avenue
London E14 9PL
Borough of Tower Hamlets

Date of Incident: 7 May 2021

Date of report: 27 June 2022

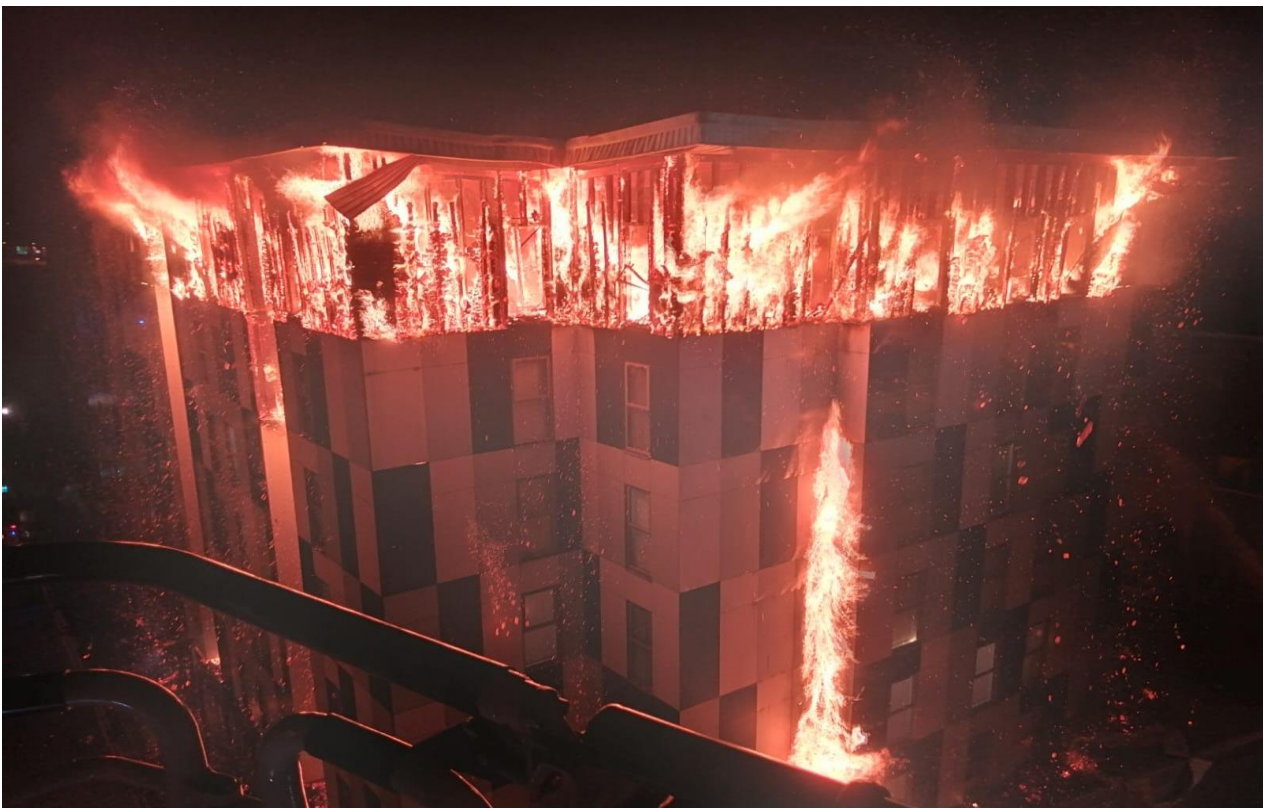
15 November 2019 'The Cube'. A multi-occupied residential building in Bolton, Greater Manchester. Rapid and unexpected fire spread was evident from the outset, severely affecting the building which featured a High-Pressure Laminate (HPL) external wall cladding system.

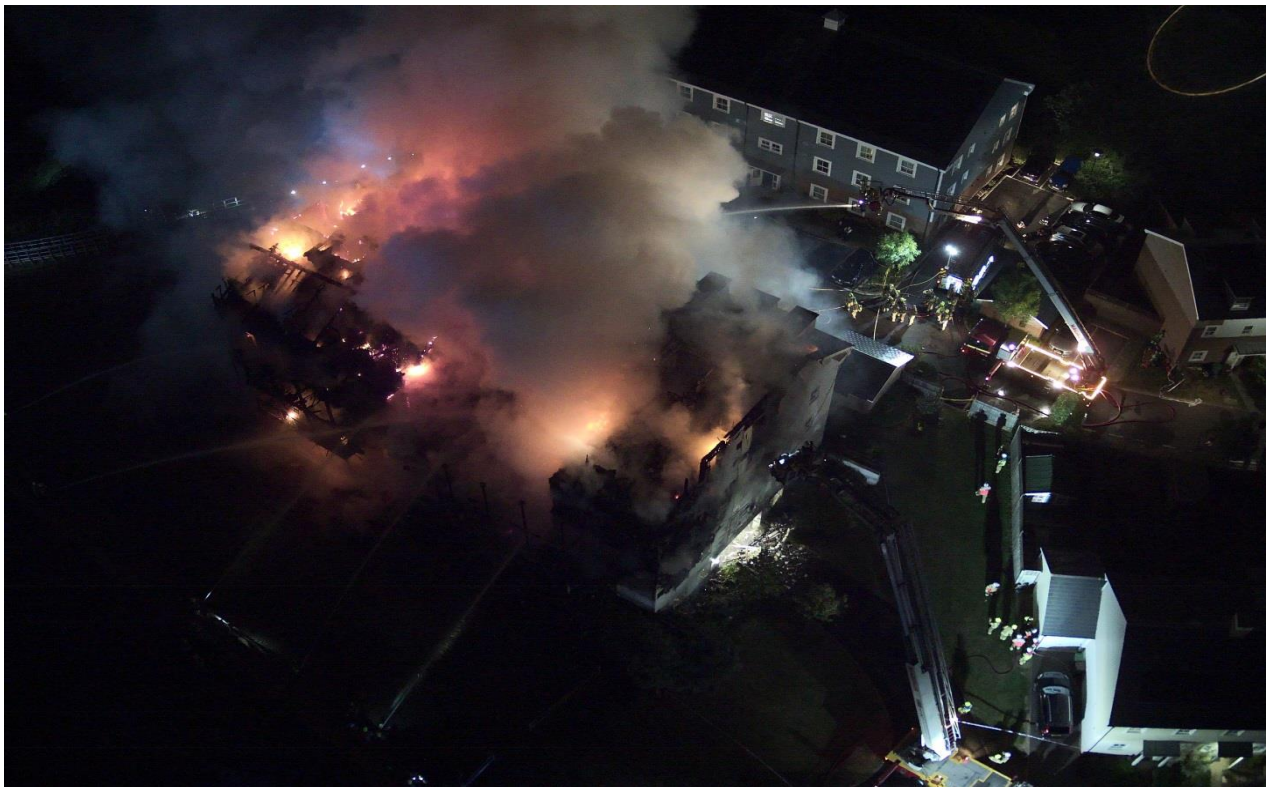
9 September 2019 Sherbrooke Way, Worcester Park, London a fire destroyed a housing block consisting of 23 homes. The building was constructed using a timber frame.

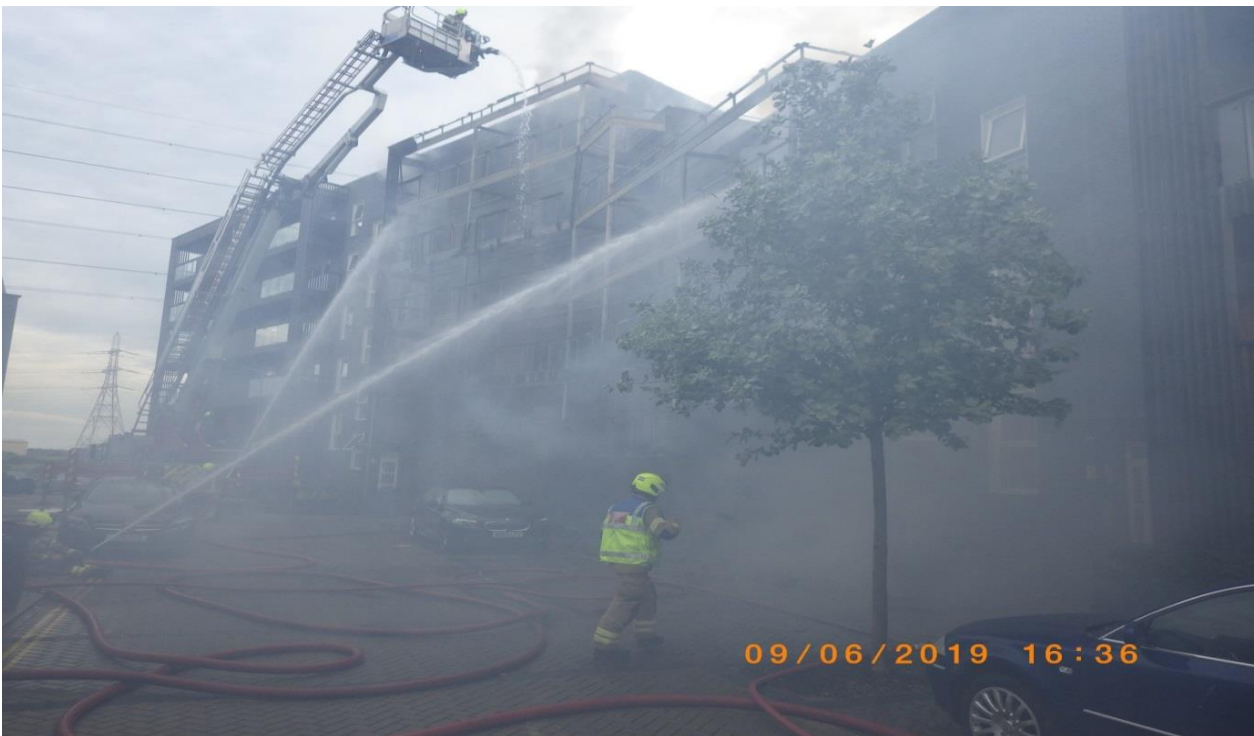
9 June 2019 De Pass Gardens, Barking, London. A fire occurred at a newly built six storey residential building. 20 flats were destroyed as fire spread via timber balconies.

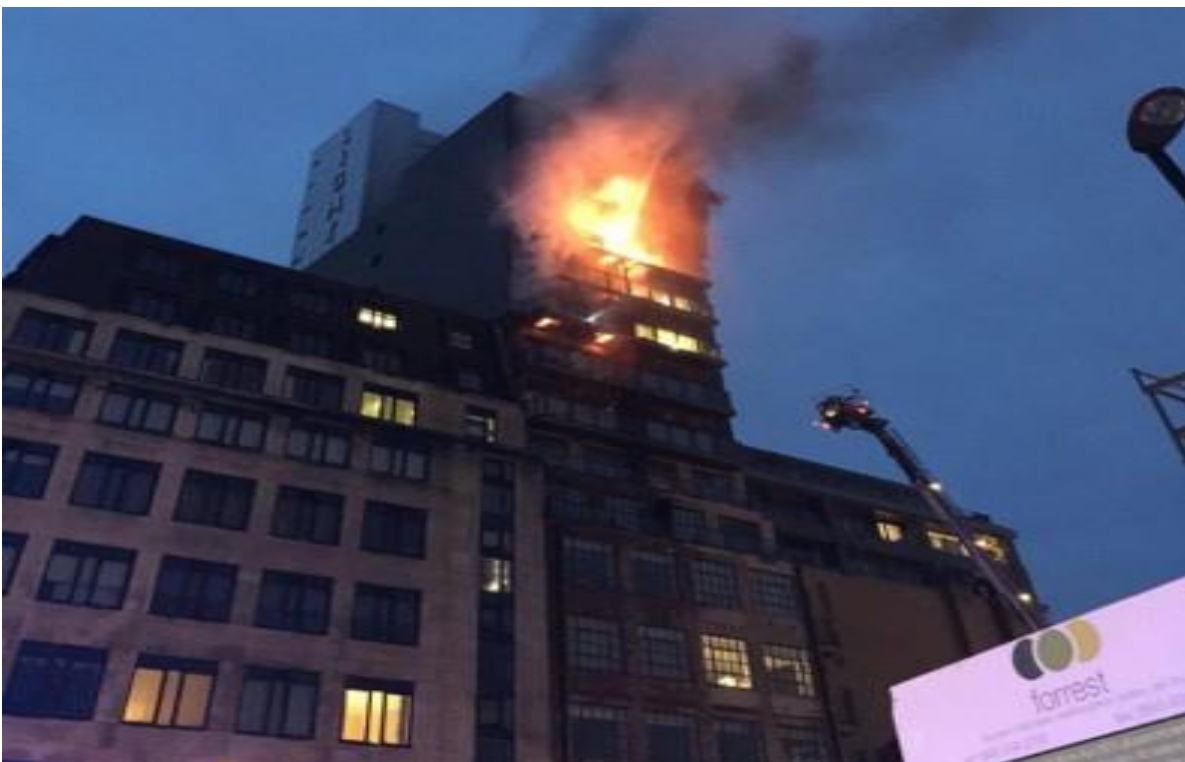
30 December 2017 Lighthouse, Manchester. Three people were treated for smoke inhalation and one person was taken to hospital after a fire broke out in Manchester city centre's Northern Quarter. It started in a flat on the ninth floor of the 12-storey block and spread externally up the 10th and 11th floors via wooden balconies.

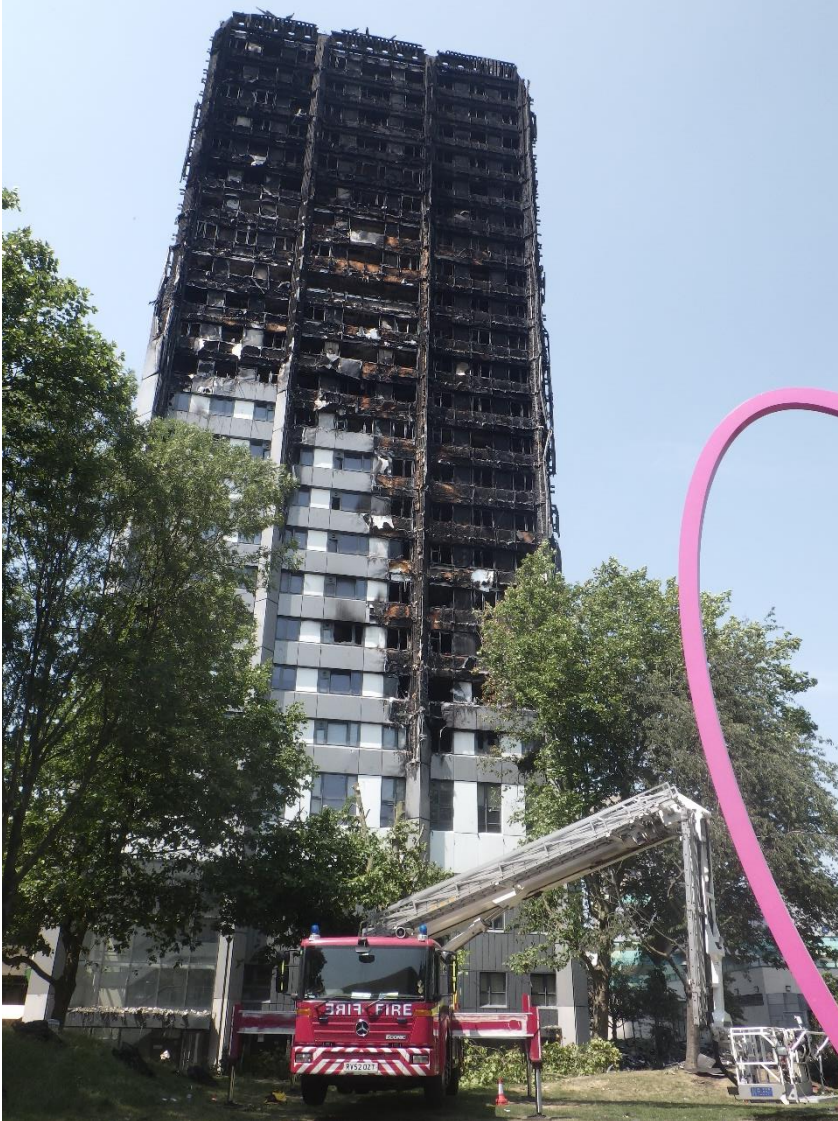
14 June 2017 Grenfell Tower, North Kensington, London. A fire broke out in the kitchen of Flat 16, Grenfell Tower. The fire spread to the external ACM cladding system resulting in extensive external fire spread around all sides of the building and internal fires between floors 4 to 23. Whilst 227 people evacuated, escaped, or were rescued from the building, the fire claimed the lives of 72 people.

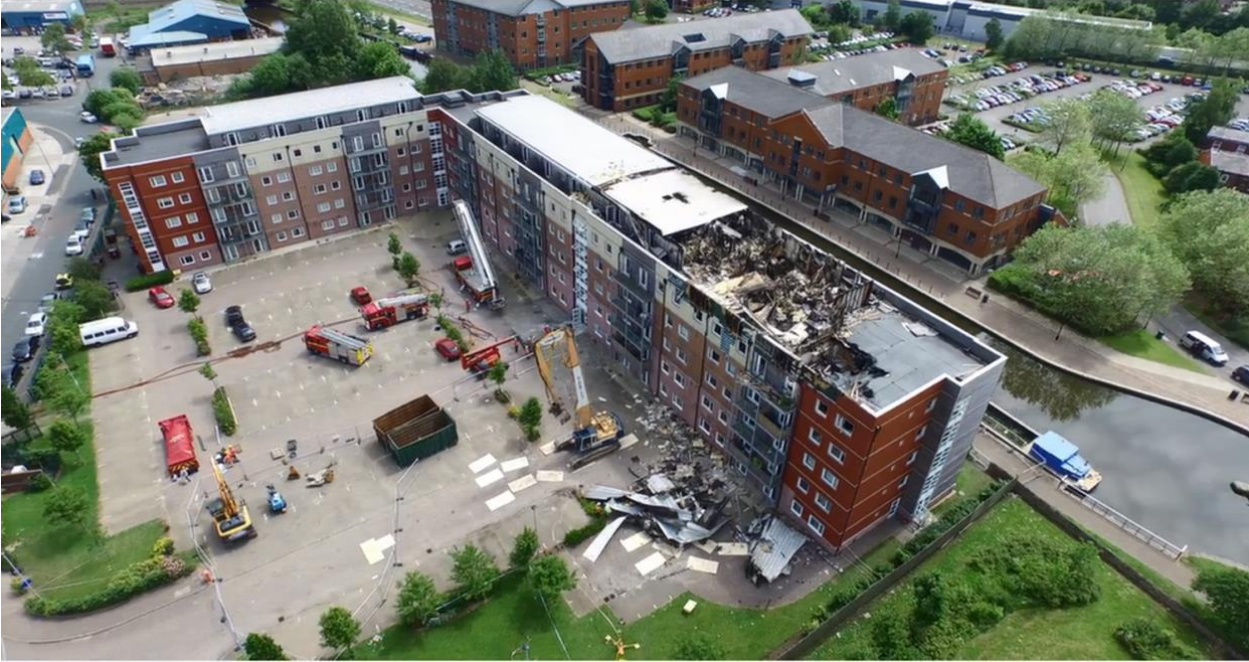
15 June 2015 Wharfside, Wigan. Greater Manchester fire and rescue service responded to a fire involving a six-storey timber framed building, on Heritage Way in Wigan. The Wharfside fire was caused by a barbeque on a balcony of the top floor. The wooden-framed structure allowed the fire to quickly spread to affect a significant part of the building. People living in 120 flats were evacuated, with many spending the night in a rescue centre or a local hotel. Over 100 firefighters were needed to deal with the fire with 32 fire engines and two aerial appliances in use at the peak of the incident.

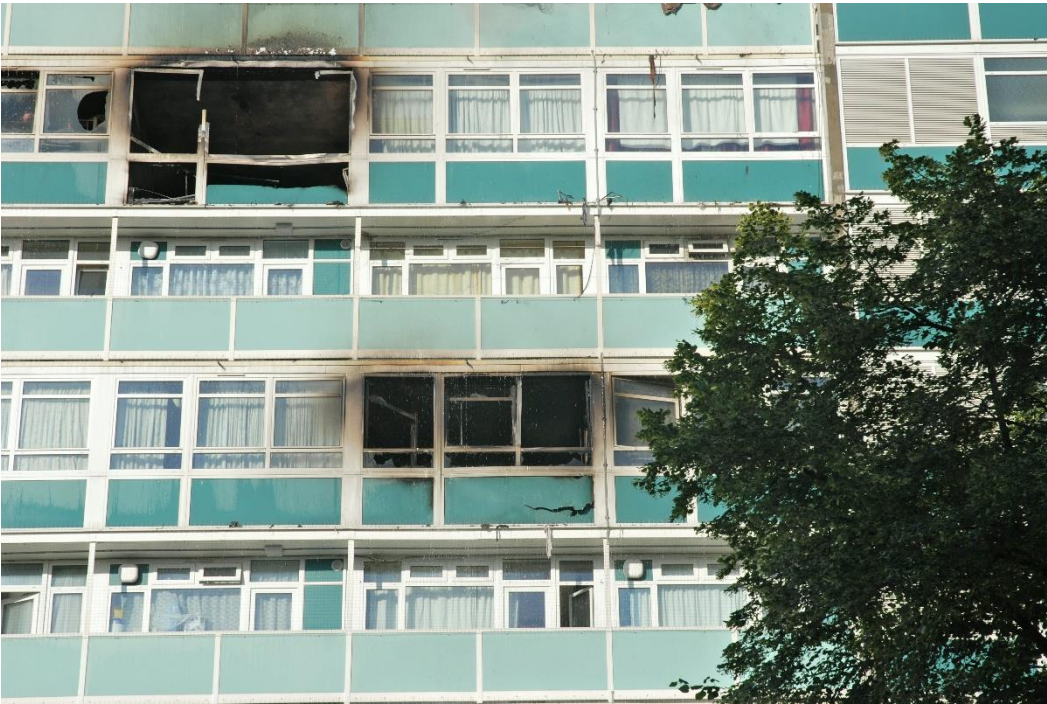
3 July 2009 Lakanal House, Camberwell, London. The Lakanal fire resulted in the loss of six lives. In addition, 15 residents and a firefighter were injured and a further 40 residents were evacuated and/or assisted to safety. Along with loss of life and injuries, over 90 families had to vacate their homes as a result of the fire.

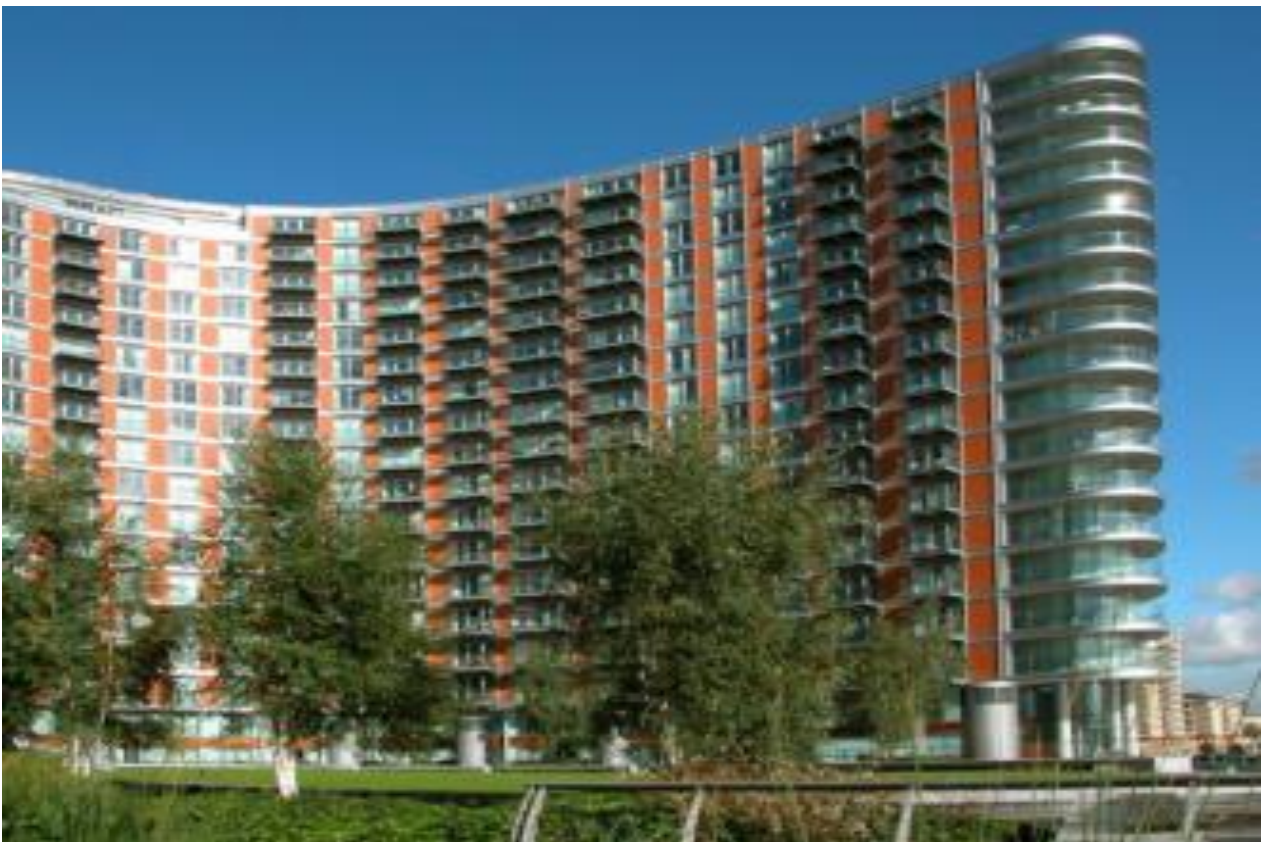
Image showing the South face of New Providence Wharf

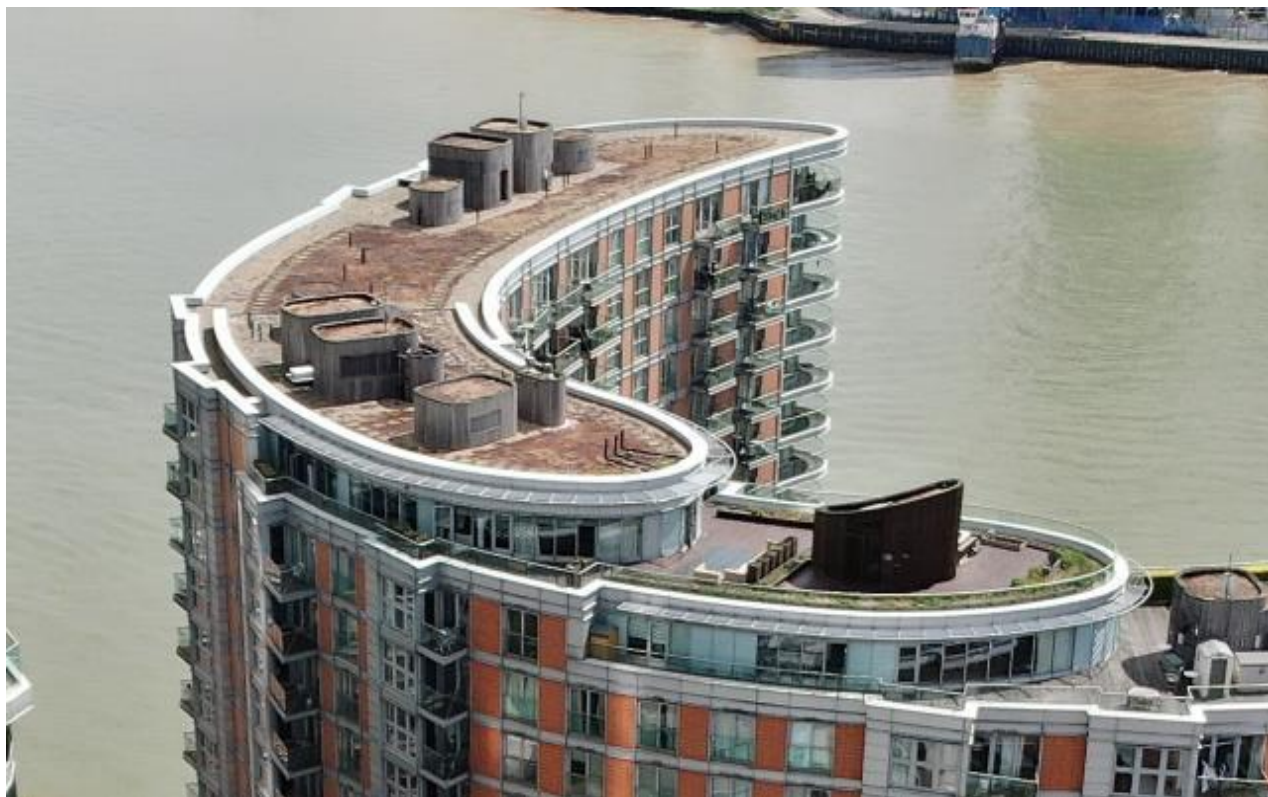
Image showing the roof of New Providence Wharf with AOV vents
