# Grenfell Tower Fire

Preliminary Report

Head of Grenfell Tower Investigation and Review  
Team

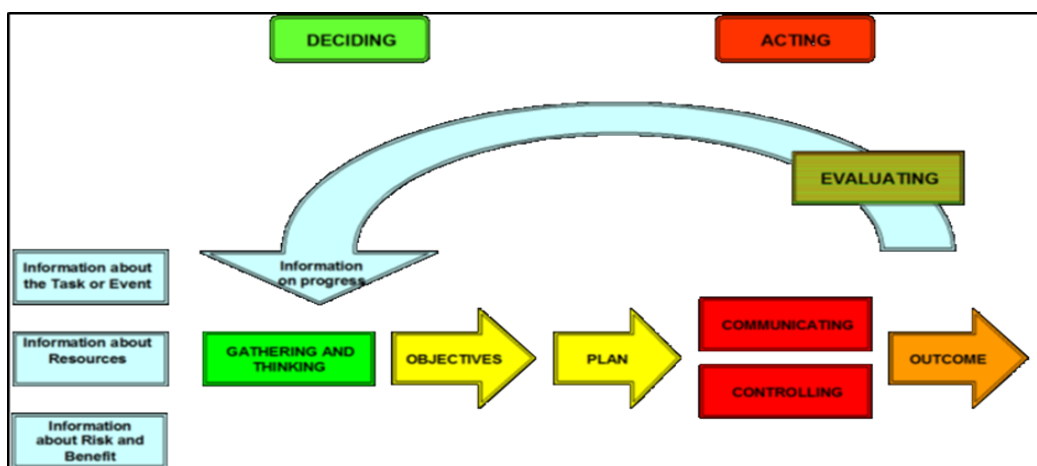
139 The DMM was included in the '*Incident Command, Fire and Rescue Service Manual*<sup>7</sup> to support commanders during their operational decision making. The model is a simple flow diagram which guides users through the decision making process in an organised way. The process aims to reduce the potential for information to be missed and requires objectives to be set and implemented. The DMM provides the framework to support Incident Commanders (IC) to manage operational incidents effectively and bring them to a safe satisfactory conclusion. A diagram is provided below for illustrative purposes.

138 The Brigade sets out its incident command framework through a series of policies owned by the OPA department. Those policies are broadly but not fully aligned to National Operational Guidance (NOG). The key difference is the Brigade currently continues to operate the Decision Making Model (DMM) it has used successfully for many years and has not adopted the Decision Control Process (DCP) included within NOG – Incident Command, published in 2016.
