# Freedom of Information request reference number: 8339.1

I would like to request under the Freedom of Information Act 2000 the most recent FRA and LFB familiarization / inspection reports for Albert House, Royal Artillery Quays, Erebus Drive, London, SE280GN

Relevant information obtained through LFB fire station familiarisation visits to buildings is recorded on the LFB Operational Risk Database (ORD). The ORD is a 'live' database, which is updated with new information as it is identified. I have attached the most recent ORD report for Albert House, SE28 dated 14 November 2023.

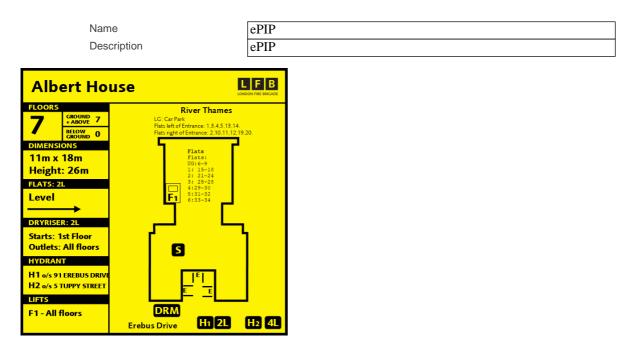
Albert House Erebus Drive

Alb	ert H	lou	se		
6 <sup>th</sup>	h	floor			33	34		
5 <sup>tl</sup>	h	floor			31	32		
4 <sup>t</sup>	:h	floor			29	30		
3'	rd	floor		25	26	27	29	
2	nd	floor		21	22	23	24	
1	st	floor		15	16	17	18	
L	JG	floor		6	7	8	9
