Freedom of Information request reference number: 8377.1

NEW PROVIDENCE WHARF, 1 FAIRMONT AVENUE, LONDON, E14
LFB Incident number: 053666-07052021 (07 May 2021)

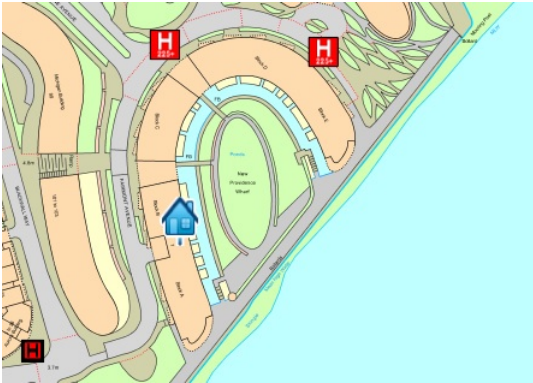
Large-Main Hydrant Locations
Note lack of vehicle access to interior of crescent...

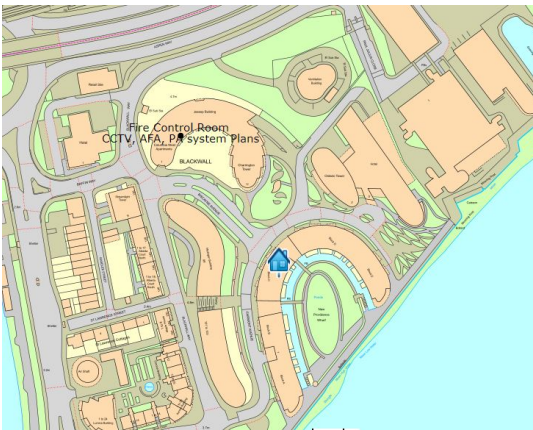
Fire control Room

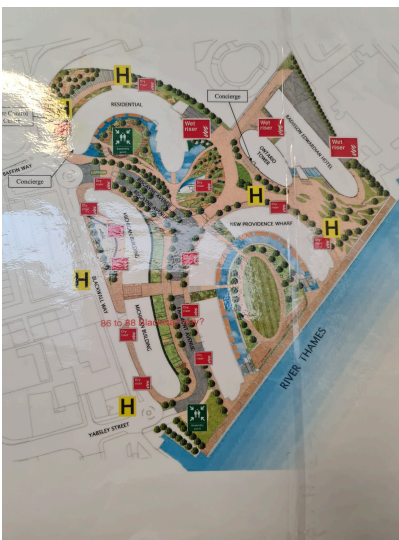
Site Overview
